Timber Pest Inspection Report

16 Aitchadar Road, Ryde NSW 2112

Inspection Date and Time: 25/07/2013 14:00

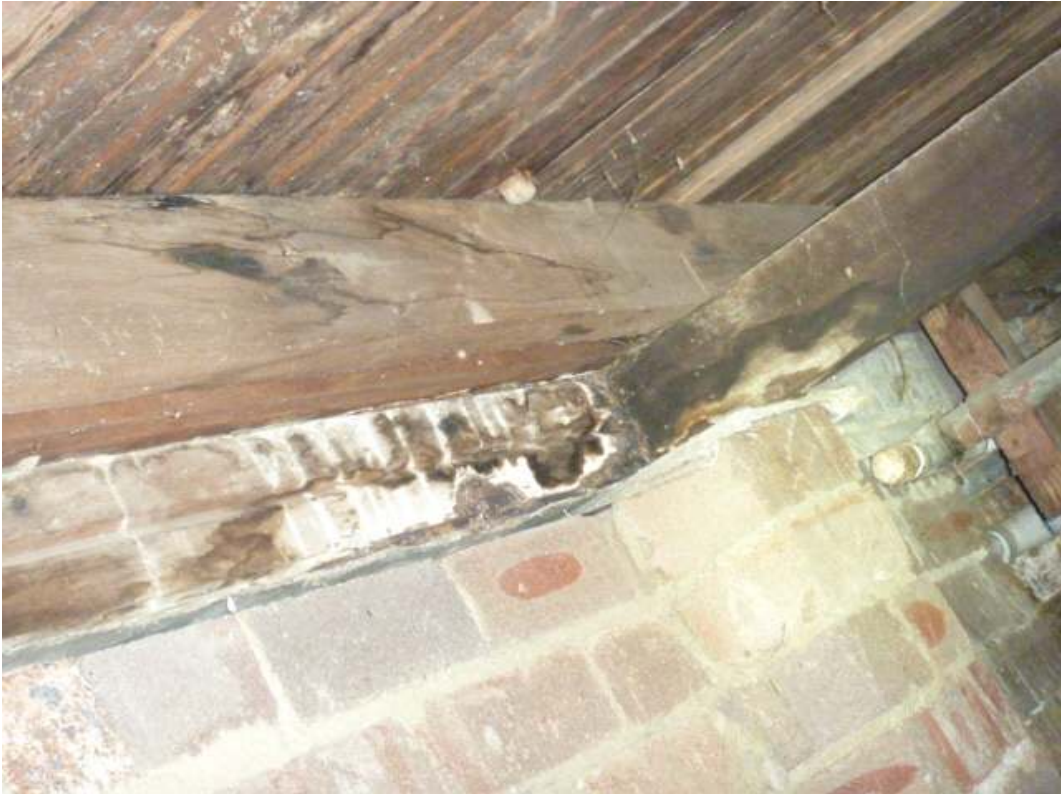
Photos for Fungal Decay

Was evidence of fungal decay found? **YES**

The condition of the timber appears: **DECAYING**

The extent of any visible damage appears: **LOCALISED**

Floor timbers in the subfloor.

Where evidence of *decaying* timber exists, competent advice (e.g. from a licensed or registered building contractor) should be sought to remove the condition(s) conducive to attack, and to determine the extent of any structural damage, and as to the need or otherwise for rectification or repair work.

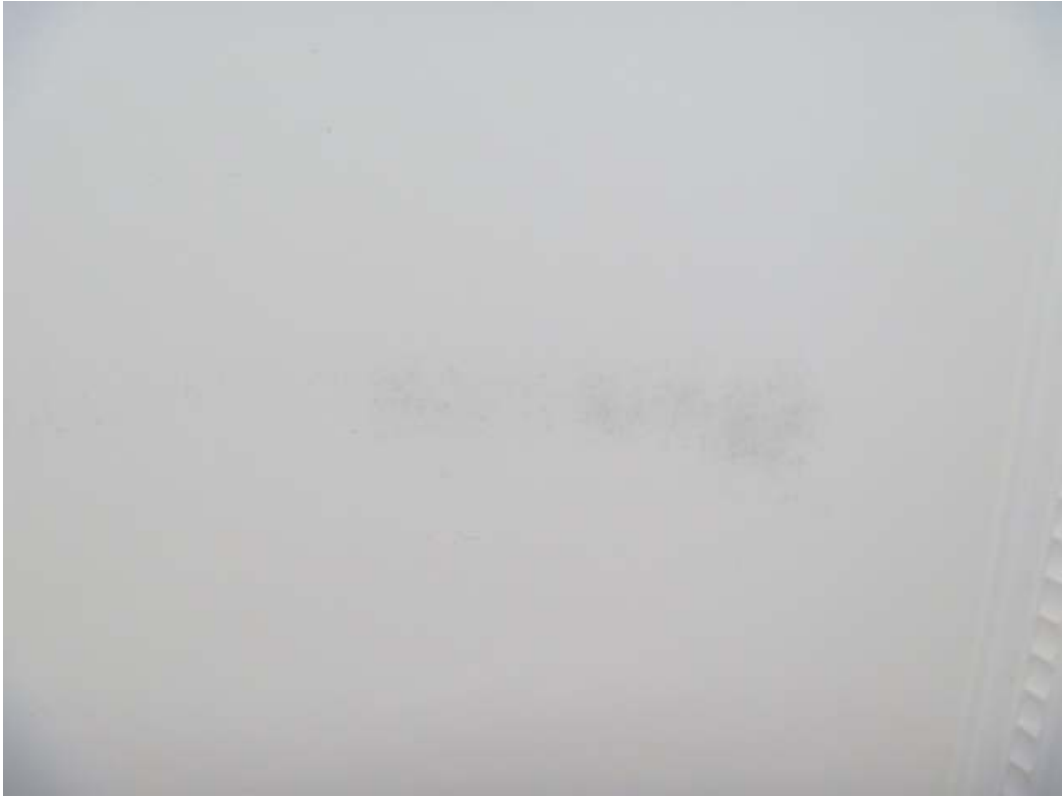
Photos for Presence of Excessive Moisture

Was evidence of mould growth found? **YES**. If YES see details and mould recommendations below.

Mould was found at ceiling lining in the hallway.

Where evidence of mould growth was noted above, there may be environmental, biological or health issues associated with this report. Any questions concerning such issues due to the presence of mould, the release of mould spores or concerning indoor air quality should be immediately directed to an appropriate qualified inspector. See also Clause A.1 – Limitation No 7.

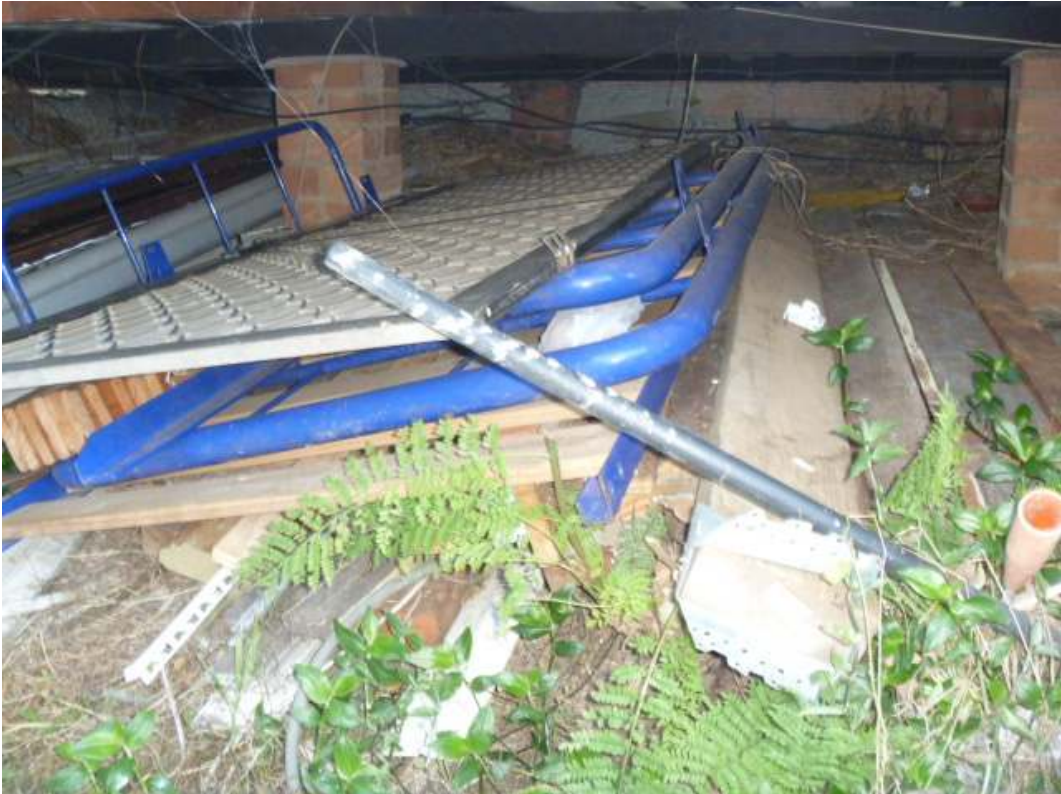
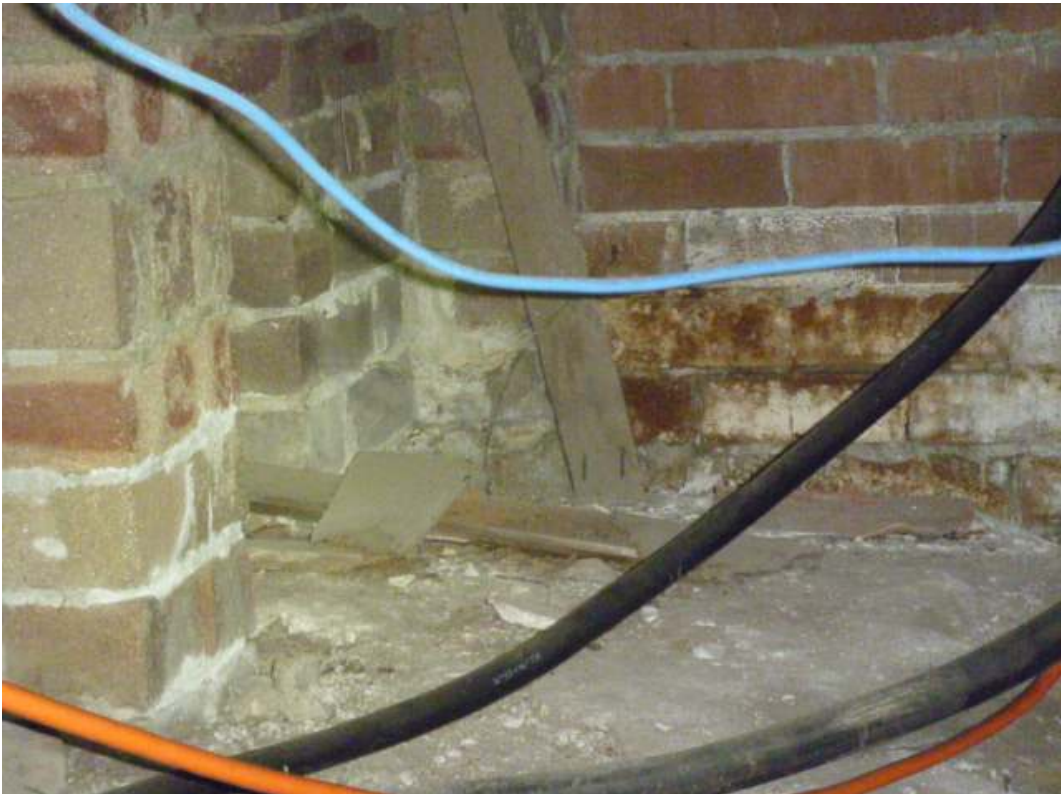
Photos for Conditions Conducive to Termite Attack

Was evidence of any other condition conducive to timber pest attack found? **YES**

Other Conditions Conducive to Timber Pest Attack If the cause or solution to a problem is not obvious, the Client should seek competent advice (e.g. from a licensed or registered building contractor) in regard to removing any conducive condition.
