# Thermal Timber Pest Inspection Report

**14 Booraba Avenue, Lindfield West NSW 2070**

**Inspection Date and Time:** 02/09/2013 11:30

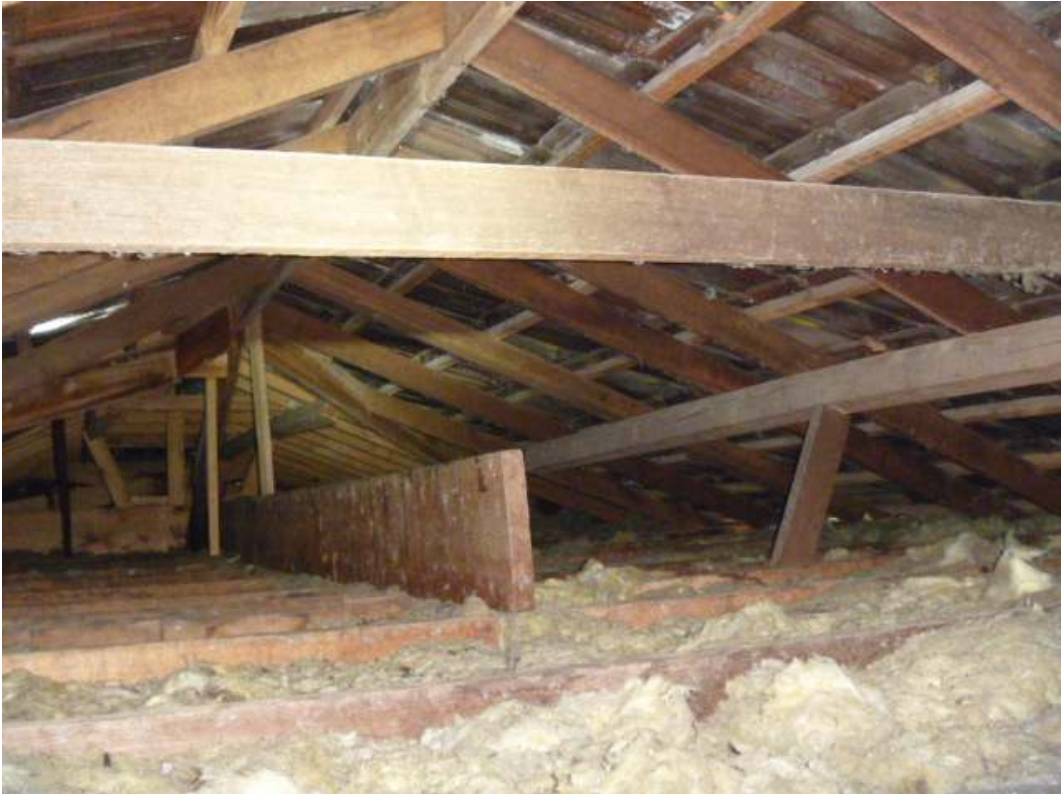
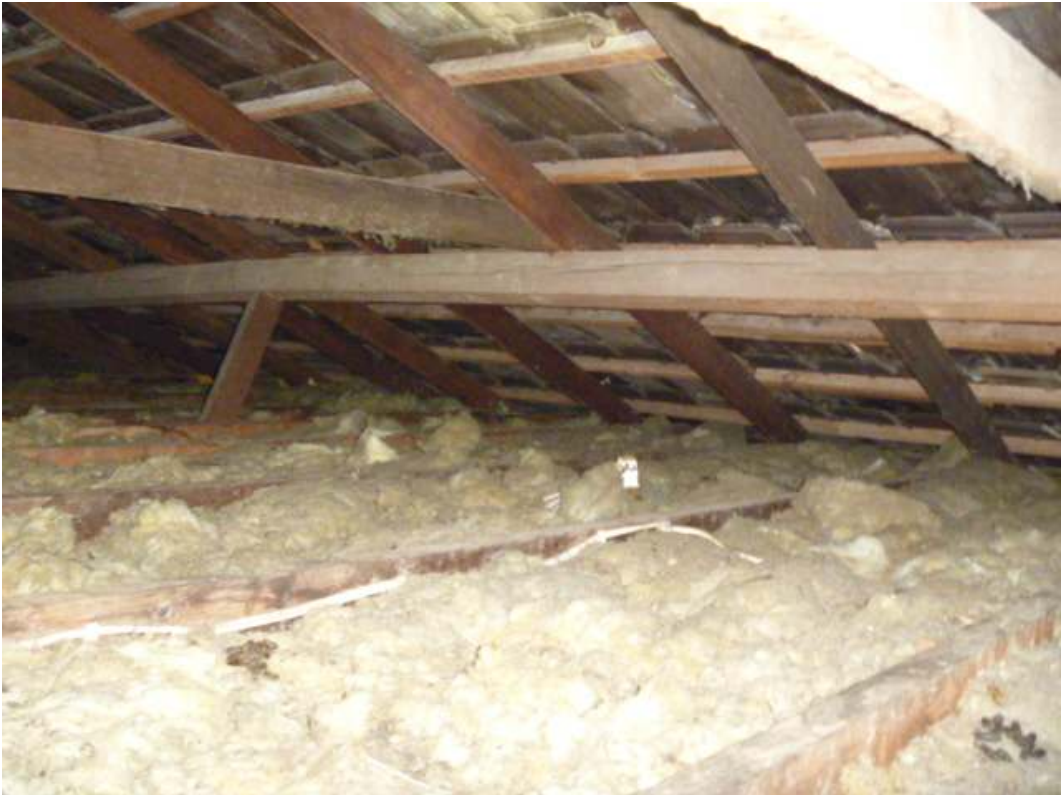
**Photos for Obstructions**

Due to the level of accessibility for inspection including the presence of obstructions, the overall degree of risk of **undetected** Timber Pest Attack and Conditions Conducive to Timber Pest Attack were considered: **MODERATE-HIGH**

**RECOMMENDATION:** Where the risk is considered “*Moderate*” or “*Moderate-High*” or “*High*”, a further inspection is strongly recommended of areas that were not readily accessible, and of inaccessible or obstructed areas once access has been provided or the obstruction removed. This may require the moving, lifting or removal of obstructions such as floor coverings, furniture, stored items foliage and insulation. In some instances, it may also require the removal of ceiling and wall linings, and the cutting of traps and access holes. Seek further advice from your Consultant.

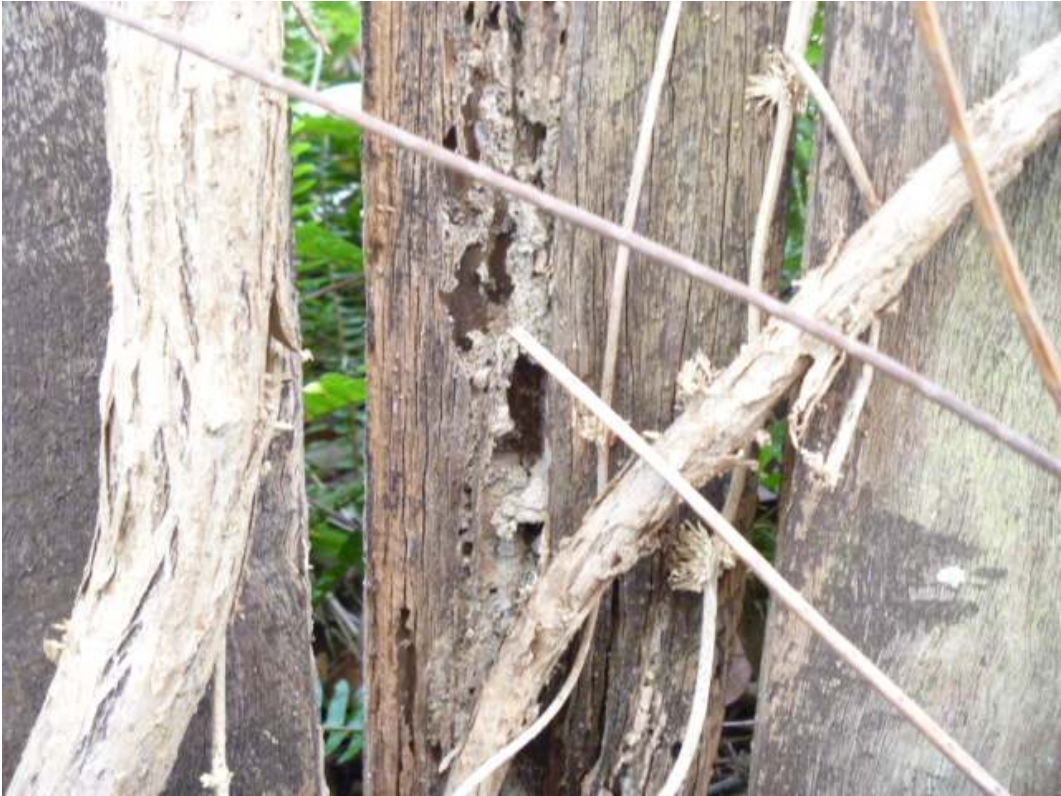
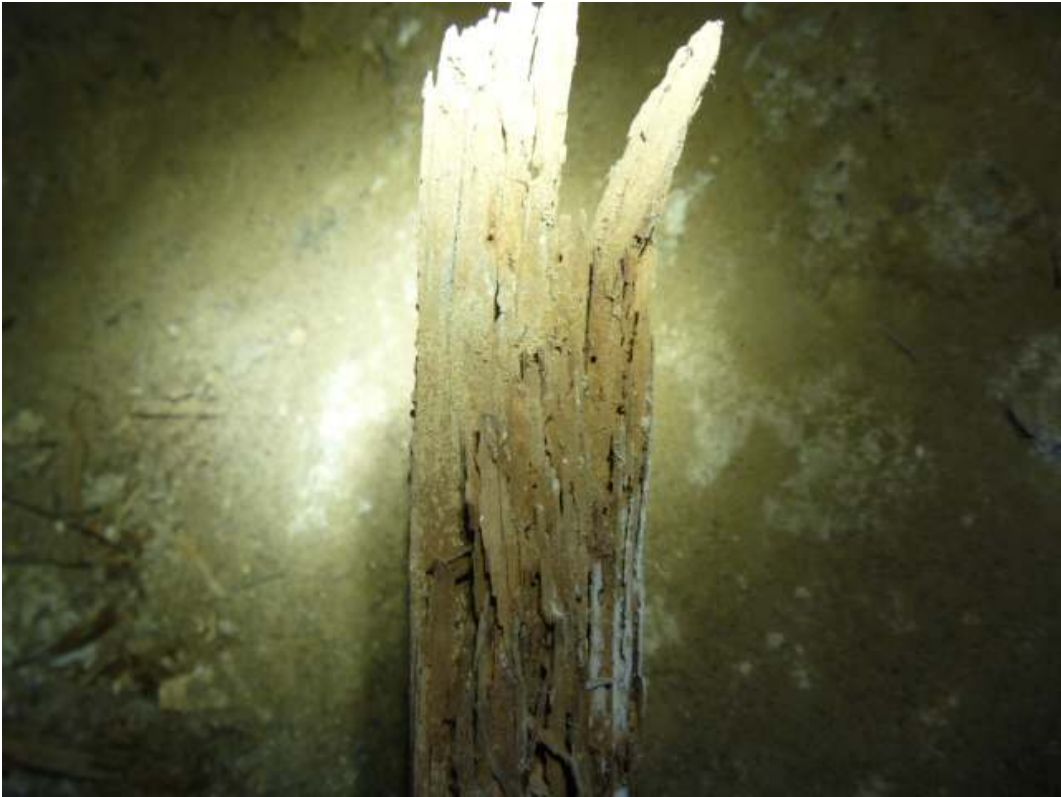
**Photos for Termite Workings and/or Damage**

Was evidence of termite workings or damage found? **YES**

The extent of any visible damage appears: **LOCALISED**

Past termite damage/activity was found at the rear timber fence and loose timbers on the ground in the subfloor.

Please note: Termite activity signed at timber fence and loose timbers in the subfloor, it is likely that the area affected by previous termite infestation can be extensive and there is likely to be some concealed damages to timber wall framing. As most of the timber structures are concealed, invasive inspection (included removal of part insulation/skirting/wall boards to reveal concealed timber framing) will be required to determine extent of termite structural damages and repairs if any.

Where evidence of damage to building timbers exists, competent advice (e.g. from a licensed and practicing building contractor) should be obtained to determine the extent of any structural damage and as to the need or otherwise for rectification or repair work. See also *Item 3.5 - Frequency of Future Inspections* recommendation.

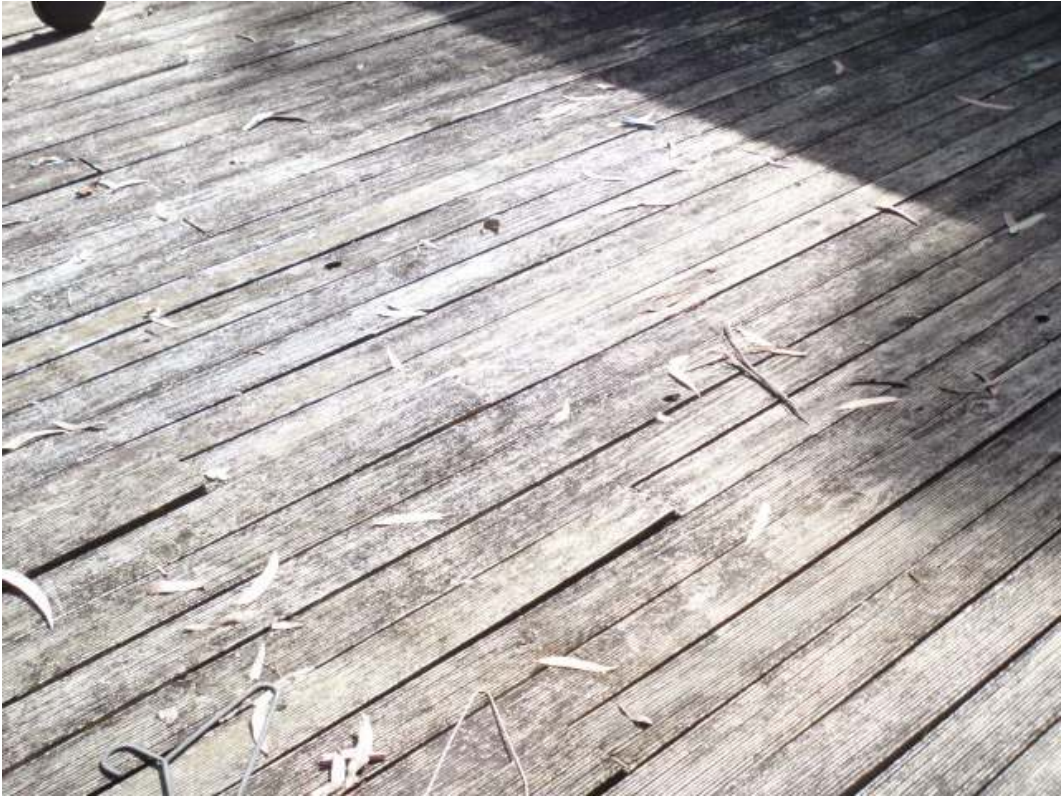
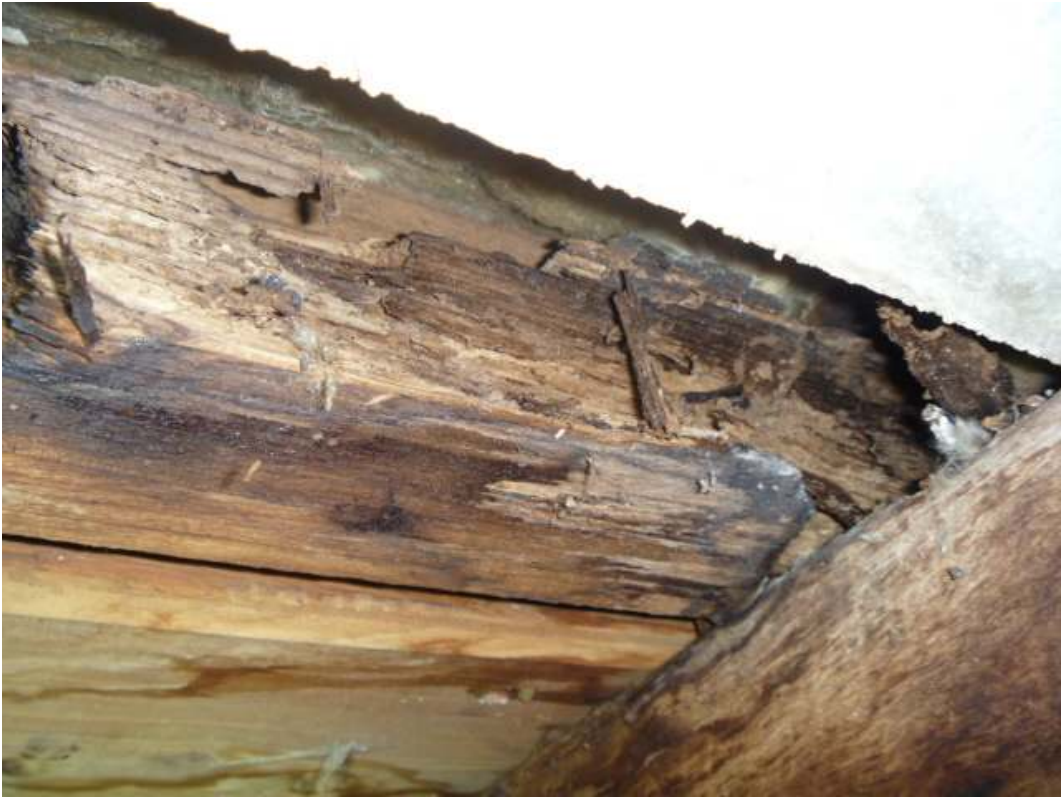
Photos for Fungal Decay

Was evidence of fungal decay found? **YES**

Timber decking and timber floors in the subfloor.

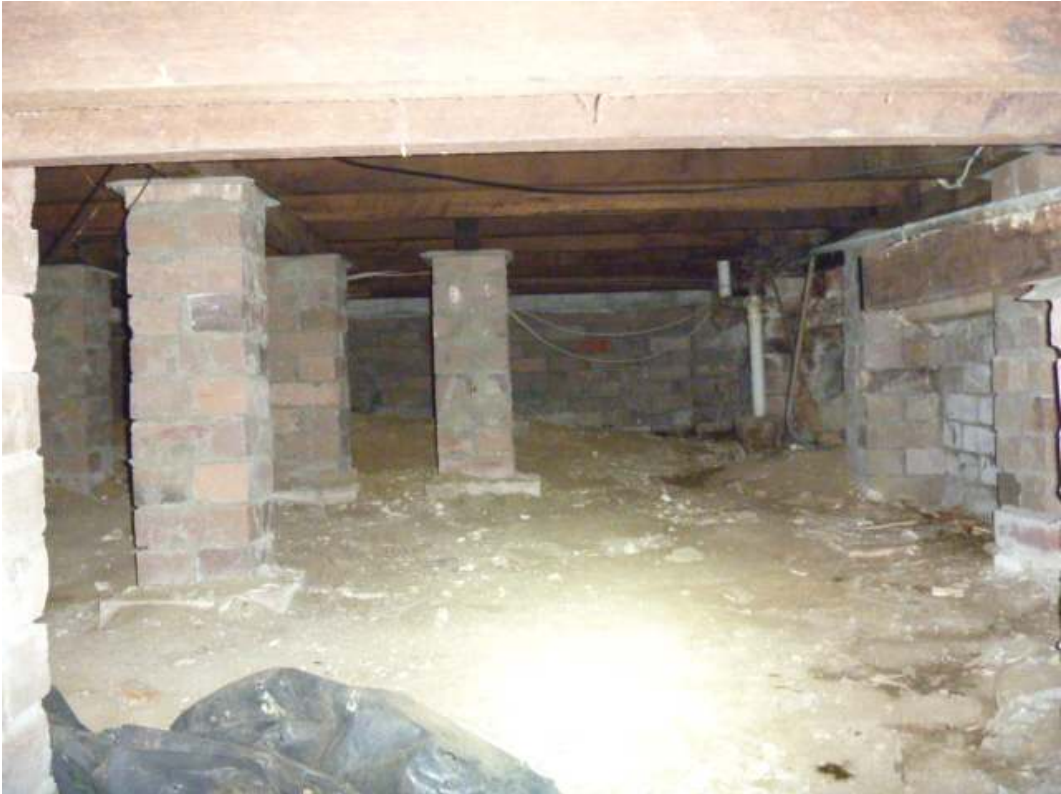
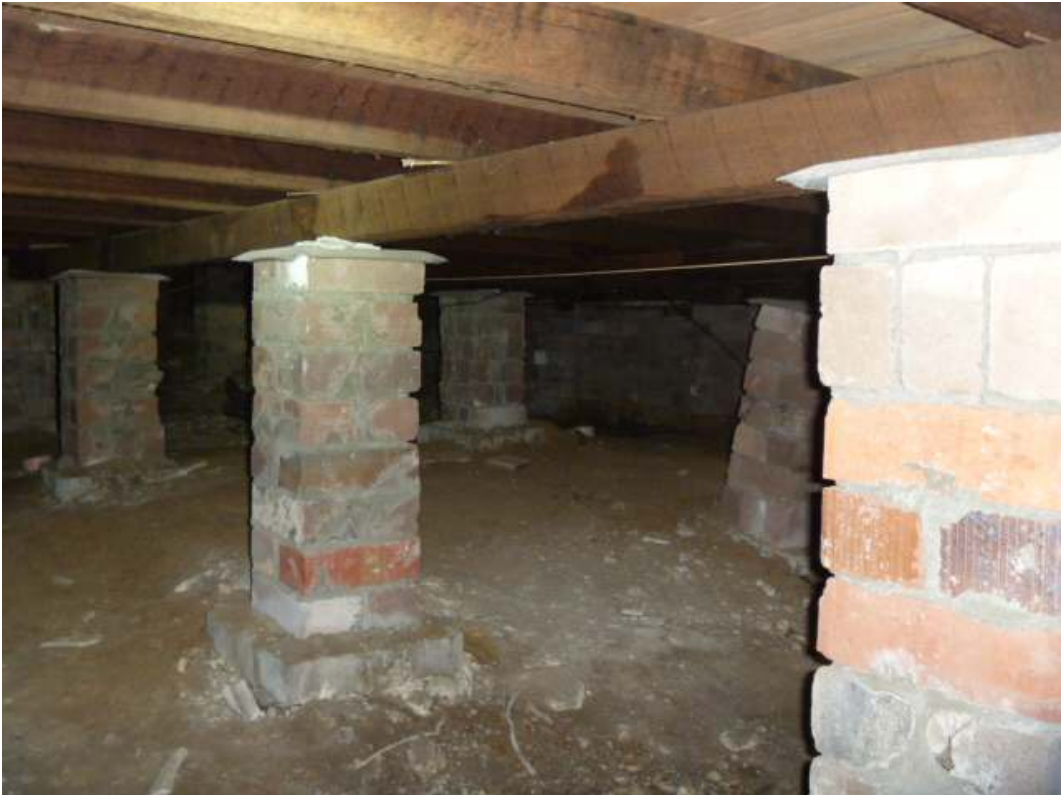
Photos for Lack of Adequate Sub-Floor Ventilation

Was evidence of a lack of adequate ventilation found? **YES**

Parts of subfloor area.

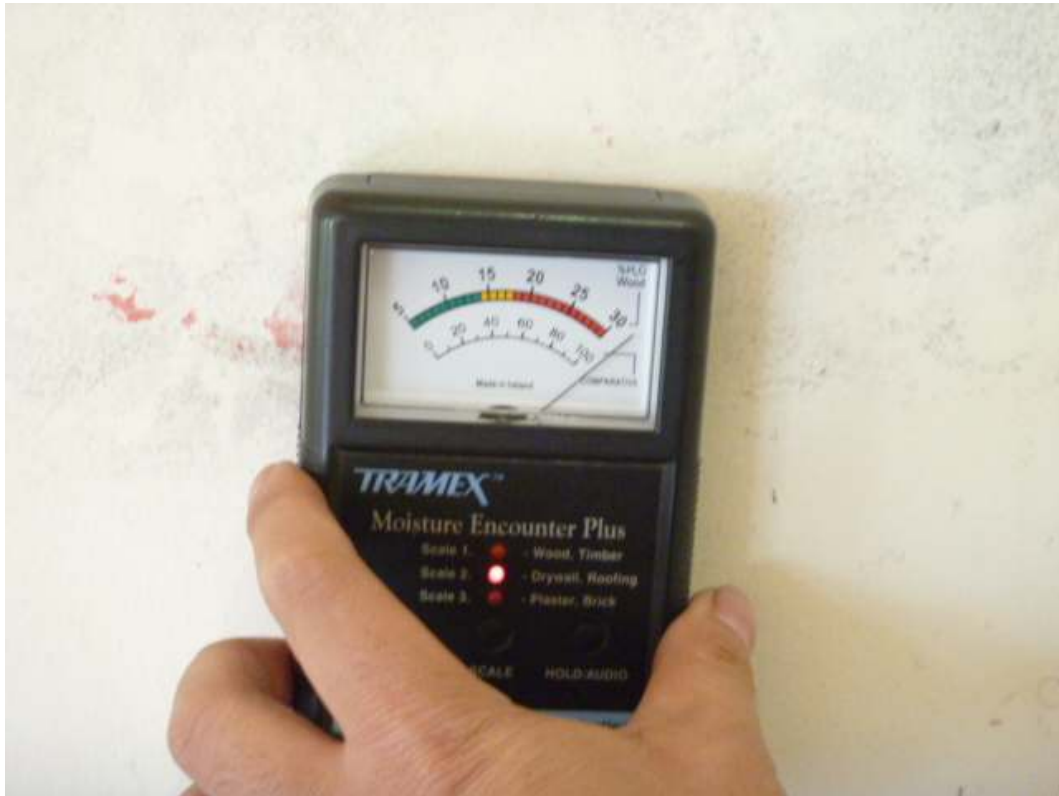
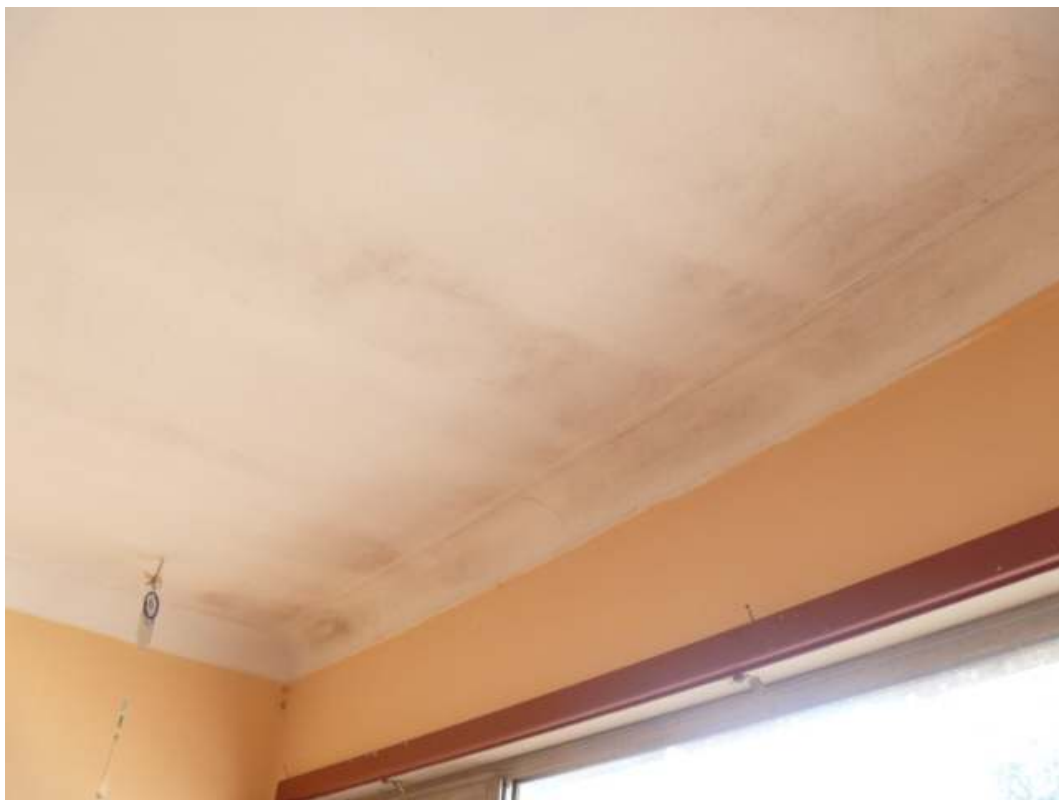
## Photos for Presence of Excessive Moisture

Was high moisture readings obtained using a moisture meter? **YES**.

Was evidence of mould growth found? **YES**. If YES see details and mould recommendations below.

High moisture readings were detected in the walls at various locations.

Where evidence of mould growth was noted above, there may be environmental, biological or health issues associated with this report. Any questions concerning such issues due to the presence of mould, the release of mould spores or concerning indoor air quality should be immediately directed to an appropriate qualified inspector. See also Clause A.1 – Limitation No 7.

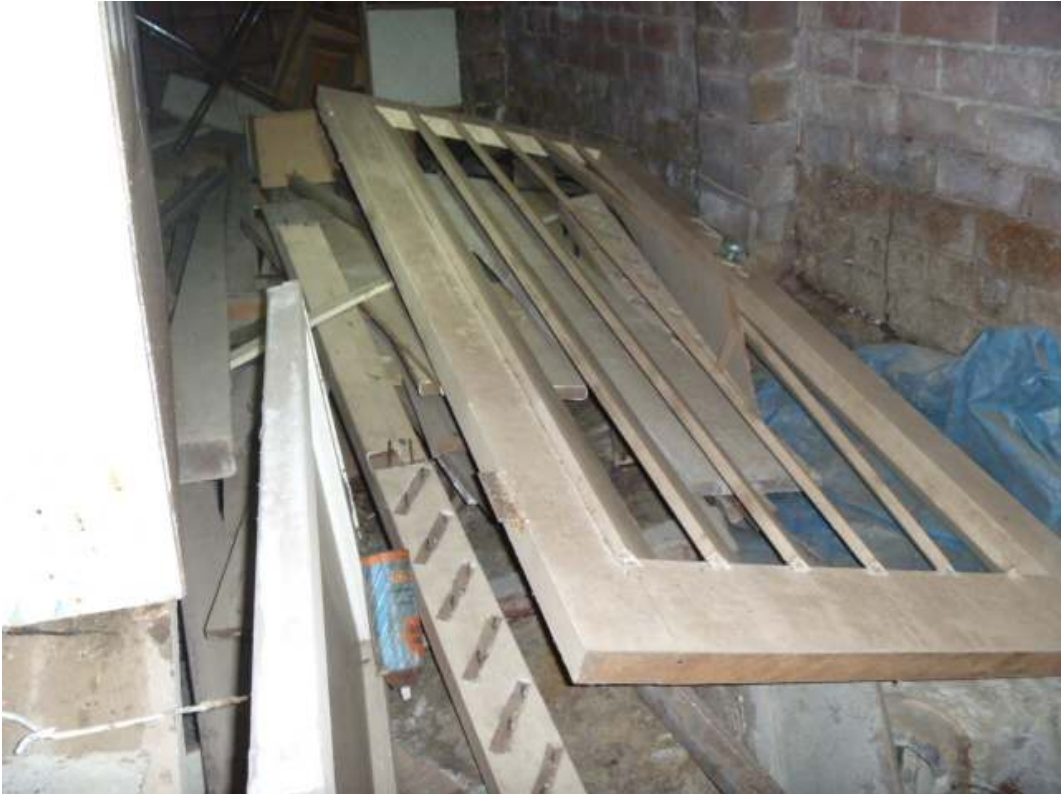
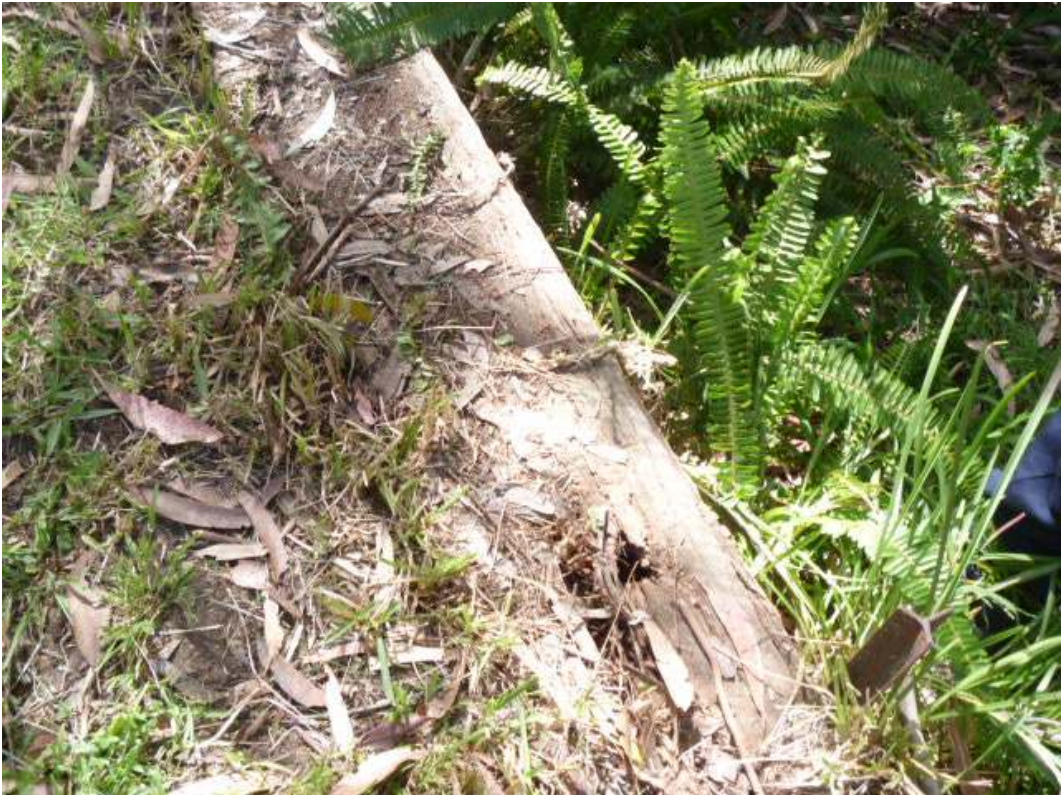
**Photos for Conditions Conducive to Termite Attack**

Was evidence of any other condition conducive to timber pest attack found? **YES**

We strongly recommend the removal of timber used as garden borders. Timbers such as this are highly attractive to termite attack and usually hidden behind the soil. Attention is required.

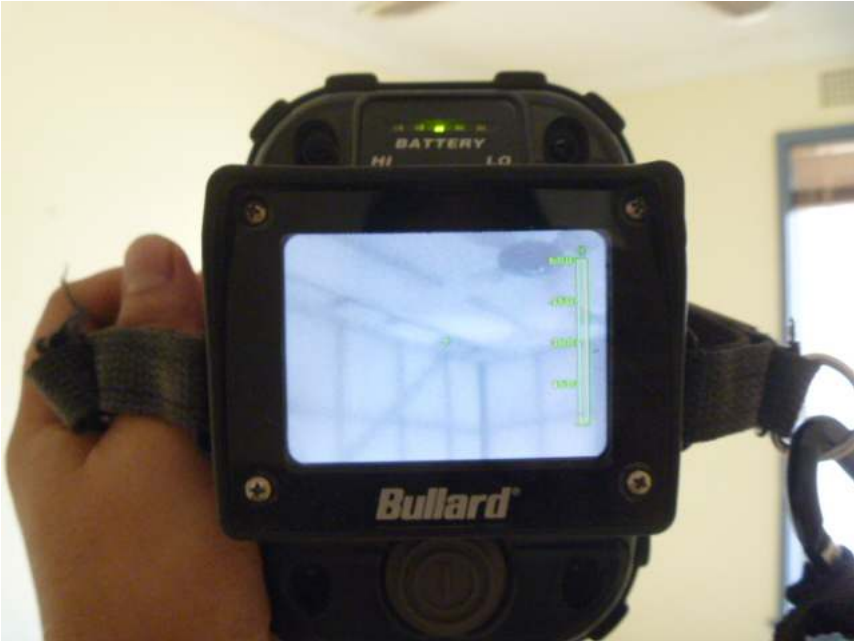
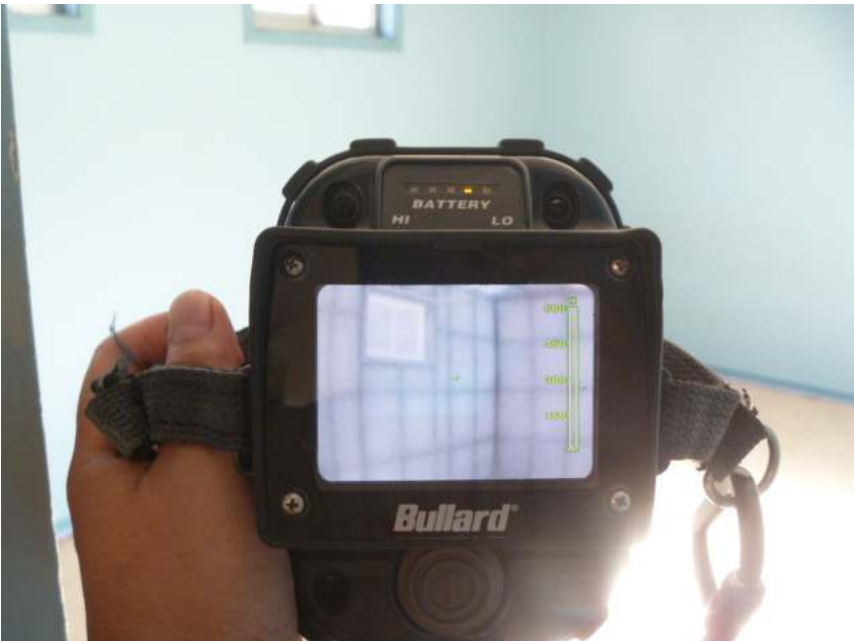
Photos for Thermal Imaging Option

During the inspection there was no thermal evidence found of active termites.
