Building Investigations Report

9 SUMMARY OF FINDINGS, OPINIONS AND CONCLUSIONS

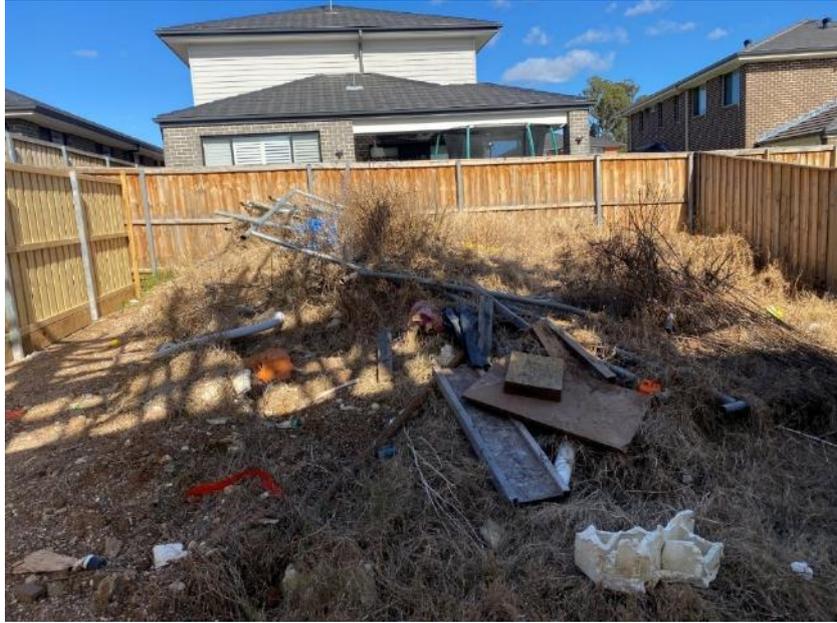
- 9) The Builder has failed to comply with the waste management plan provided as part of the Complying Development Application. There is excess spoil, debris and construction materials that has been stored at the front and rear of the dwelling which has not been removed as required on the contract. As per the site provisions on the tender documentation to the Owner, “waste management from commencement to completion” has been allowed, however the waste materials on site have not been removed. The failure to remove the excess spoil, debris and construction material contravenes Part 2C – Section 18B of the Home Building Act. Figures 1 and 15 in Appendix C show images of approximately 11m³ of excess construction waste that has not been removed as required in the building contract.

Figure 1. Residue debris that has been discarded in the rear yard. Approximately 1m3.

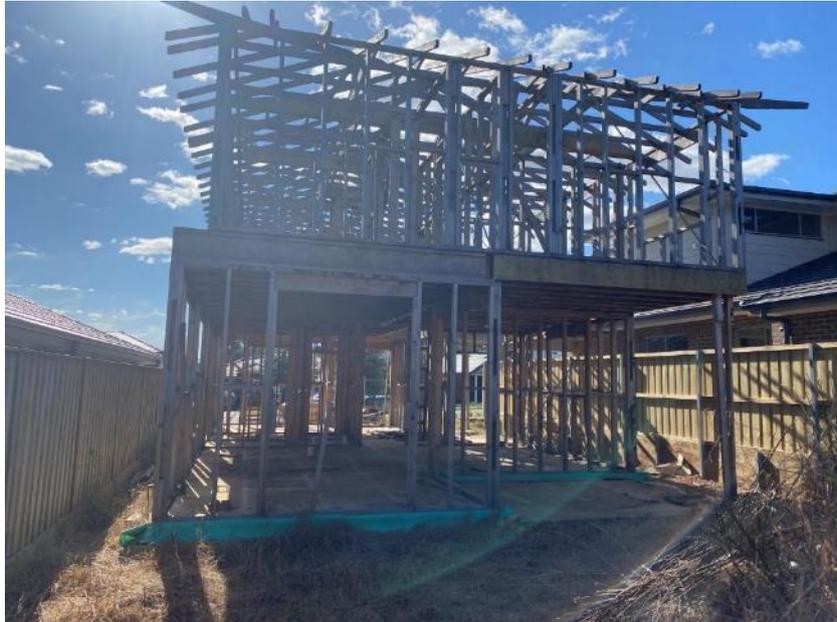
Figure 2. General condition of the southern elevation.

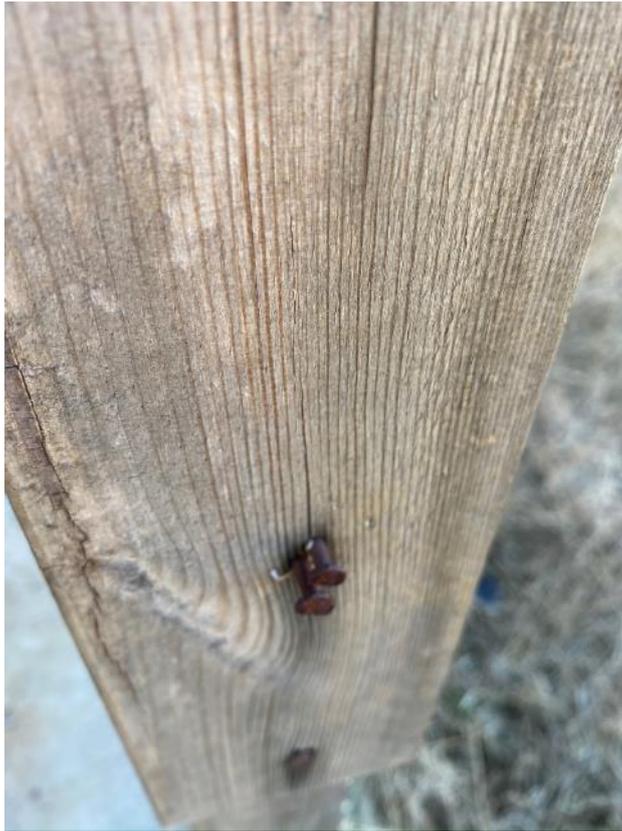
- 4) There is evidence of corrosion to the metal wall and floor fixings throughout the dwelling – see figure 3, 26 and 27 in Appendix C of this report. The corrosion of the nails adversely affects the bonding capacity between the timber framing, which can result in the structural failure of the dwelling. In my opinion, the corrosion in the nails contravenes The Building Code of Australia Volume 2, Part 2.1.1 Structural stability and resistance to actions.

Figure 3. Corrosion noted to the nail fasteners throughout the dwelling.

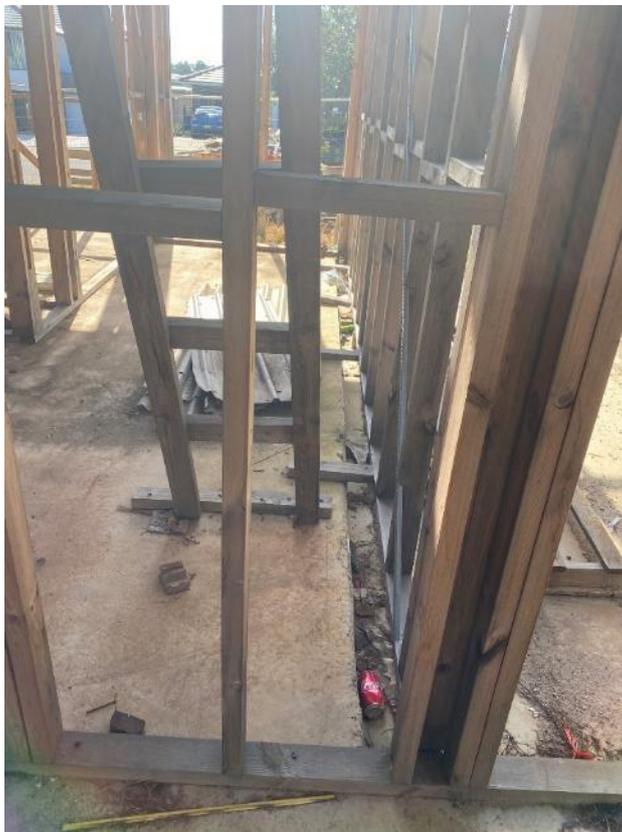
- 5) Water ingress into the timber frame on the ground floor and first floor has resulted in a reduced structural capacity of the timber. Images of the water damaged timber can be seen in figures 4, 8, 9, 13, 17, 23, 24 and 34 in Appendix C of this report. The exposure to weather has resulted in the construction of the timber wall frames to contravene The Building Code of Australia Volume 2, Part 2.1.1 Structural stability and resistance to

Figure 4. Water damage to the ground floor timber frame in the stair void area.

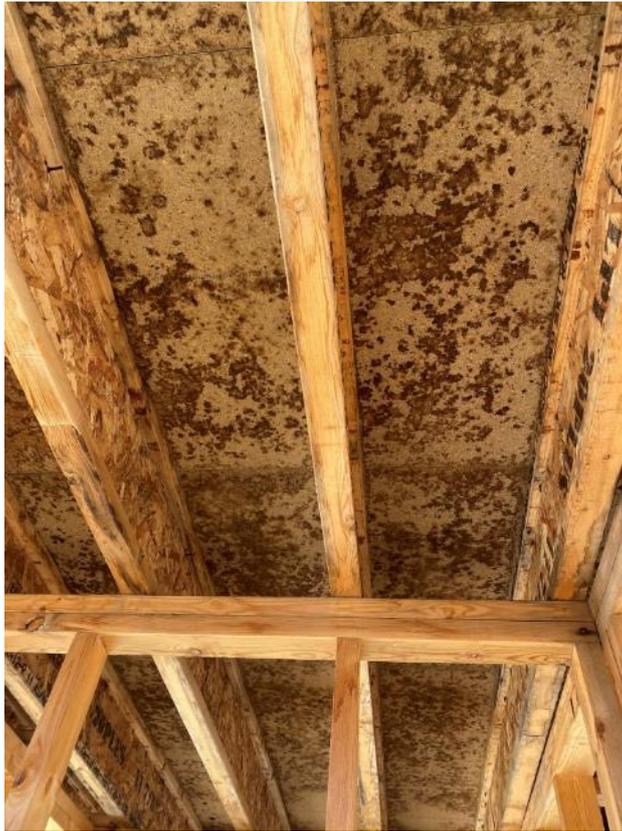
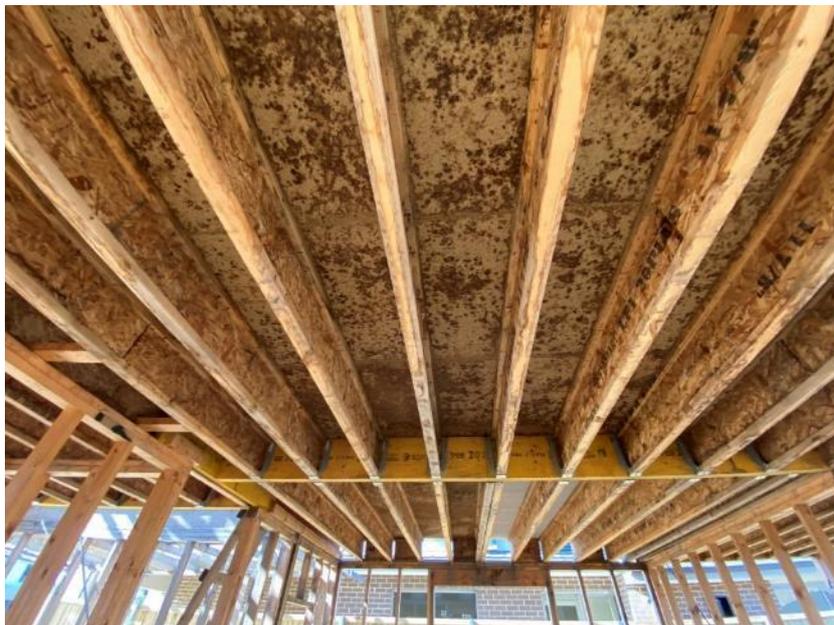
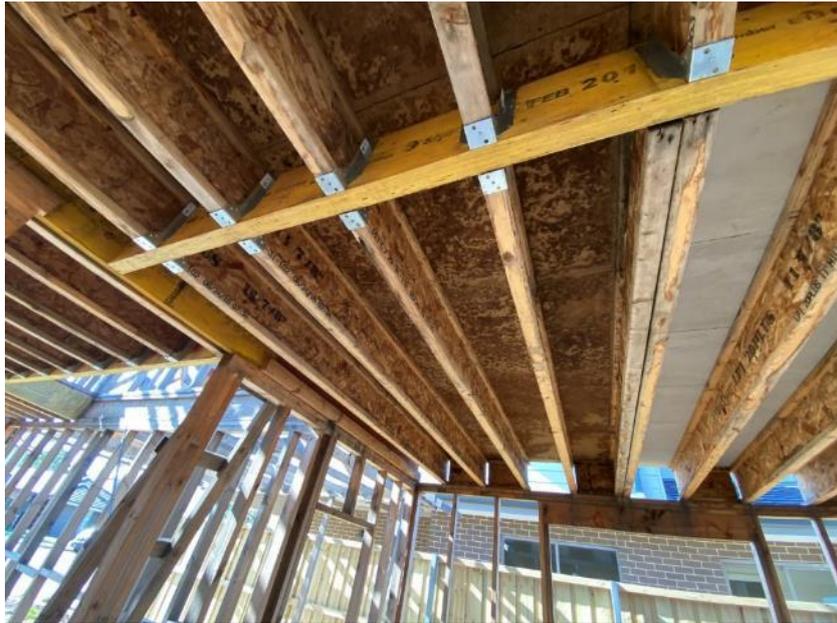
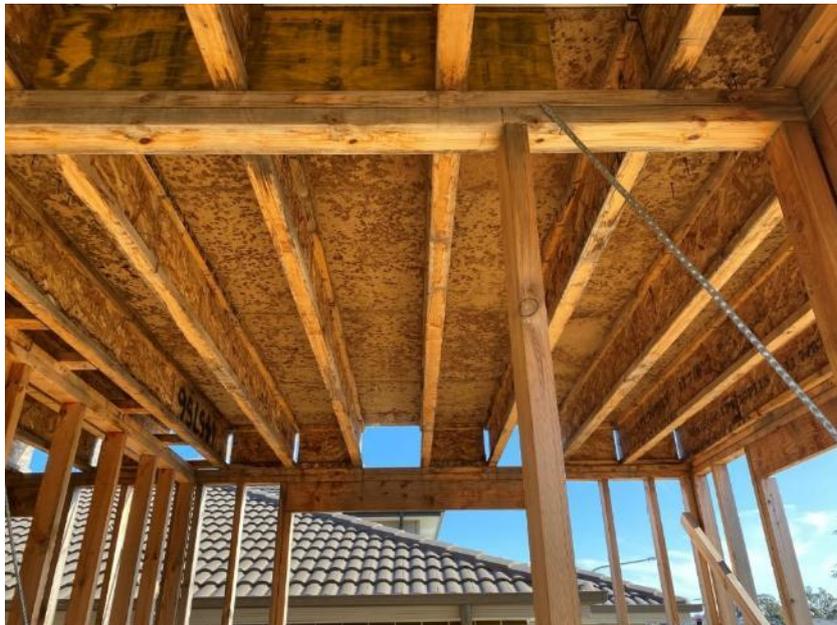
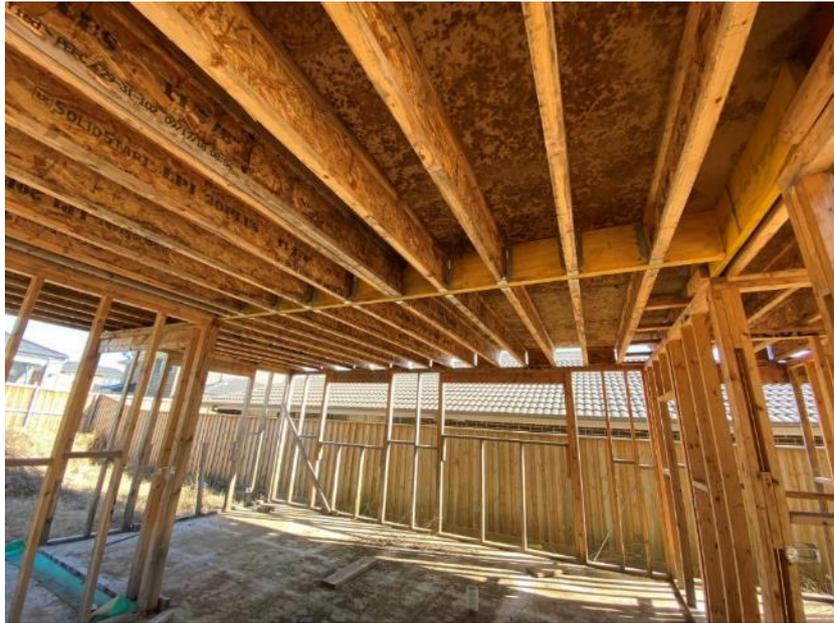
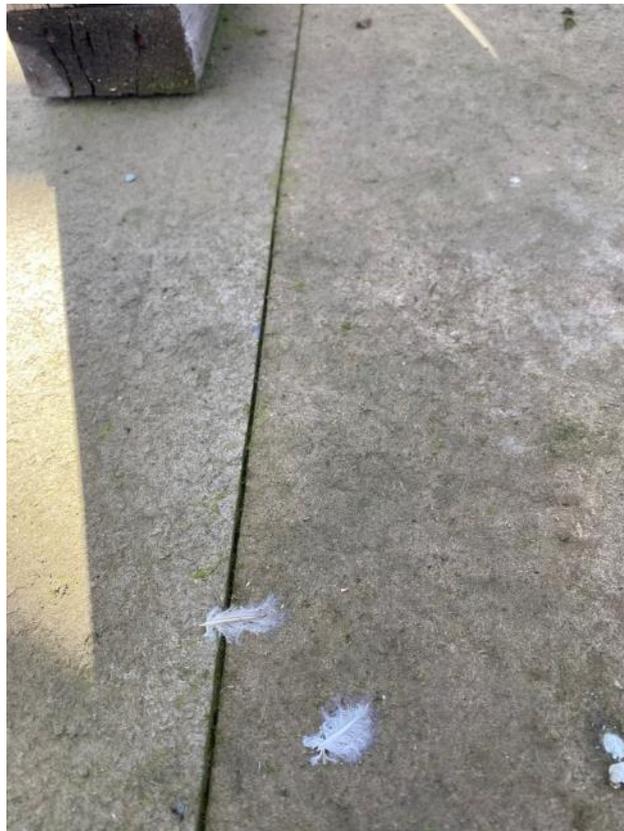
- 2) Figure 2.7 in the Halina Consulting report identified that the floor sheeting on the first floor has been exposed to weather for a few months, which has resulted in a reduction in structural capacity. From my inspection, the particleboard floor sheeting has since deteriorated further and has resulted in mould growth. The Builder's failure to cover the floor sheeting has resulted in water ingress into the particleboard floor. In my opinion, the water ingress into the floor sheeting will result in failure of the flooring structure when permanent and imposed actions are applied to the floor sheeting, which contravenes The Building Code of Australia Volume 2, Part P2.1.1 Structural stability and resistance to actions. Additional photographs of the damage can be found in figures 5, 6, 7, 18, 19, 20, 21, 22, 26, 27 and 28 in Appendix C.

Figure 5. Mould and water damage to the particleboard flooring to the first floor.

Figure 6. Mould and water damage to the particleboard flooring to the first floor.

Figure 7. Mould and water damage to the particleboard flooring to the first floor.

Figure 18. Mould and water damage to the particleboard flooring to the first floor.

Figure 19. Mould and water damage to the particleboard flooring to the first floor.

Figure 22. Mould and water damage to the particleboard flooring to the first floor.

- In order to facilitate to the replacement of the particleboard flooring identified in item 2 in section 9.1, the removal of the first floor wall and roof frames will be required.
- The water damaged timber identified in items 3-7 in section 9.1 will require replacement due to warping and a decreased structural stability and resistance to actions because the timber cannot be reused or treated in order to achieve a satisfactory standard that will be suitable for residential use.

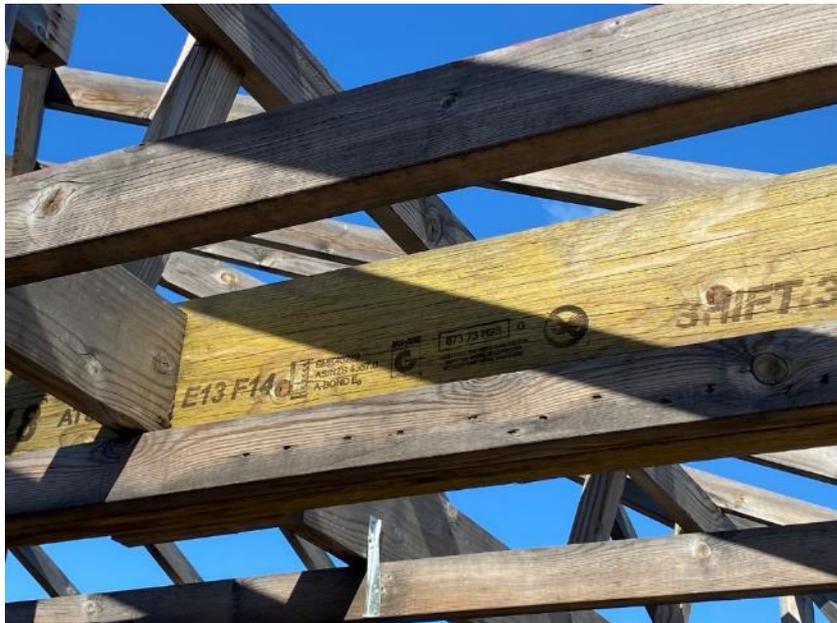
- 3) The timber wall frames on the ground floor and first floor have deteriorated and resulted in splitting of the timber beams and wall frames – see figures 8, 10, 11, 12, 23 and 34 in Appendix C. The splitting of the timber beams and wall frames will result in an adverse effect on the structural integrity of the structure. The failure to adequately support a structure contravenes The Building Code of Australia Volume 2 Functional statement F2.1, which states in part:

Figure 8. Water damage to the timber beam in the first floor northern bedroom.

In my opinion, due to the compounded nature of the weather-damaged timber structure, it is most economical to remove and replace all timber structural members within the dwelling to ensure for compliance with The Building Code of Australia Volume 2, Part 2.1.1 Structural stability and resistance to actions. The rectification cost of these works are outlined as part of the Scott Schedule in Appendix D.

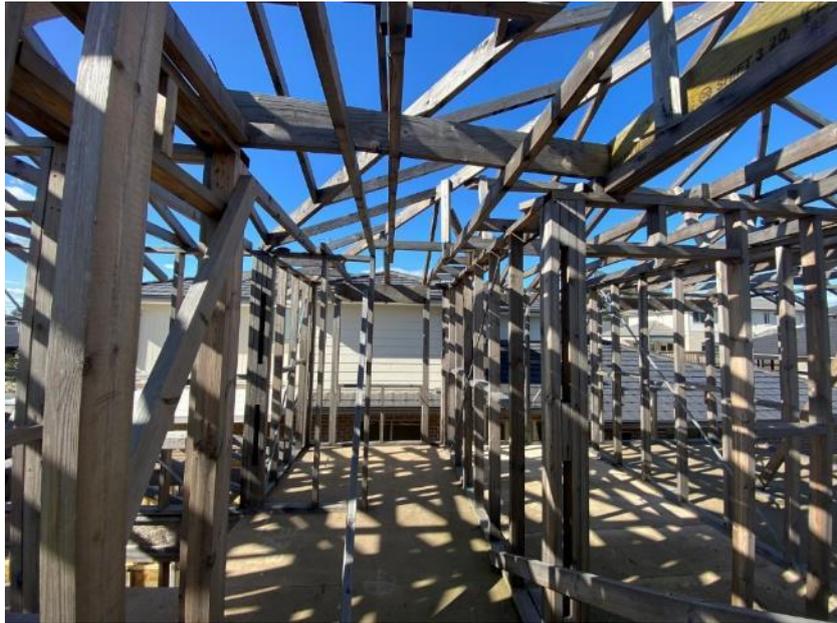
Figure 9. Water damage to the timber wall structure on the first floor.

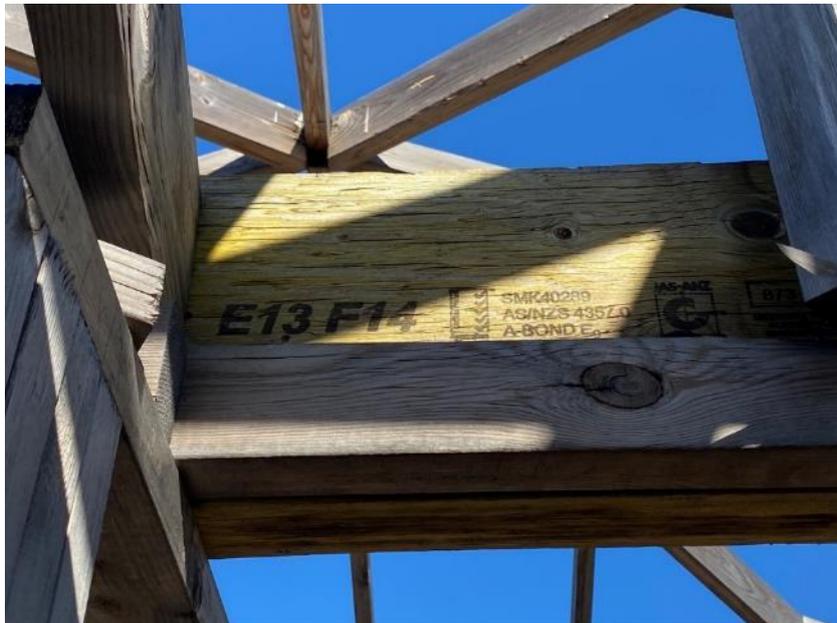
Figure 10. Splitting of the timber beam above the northern first floor bedroom.

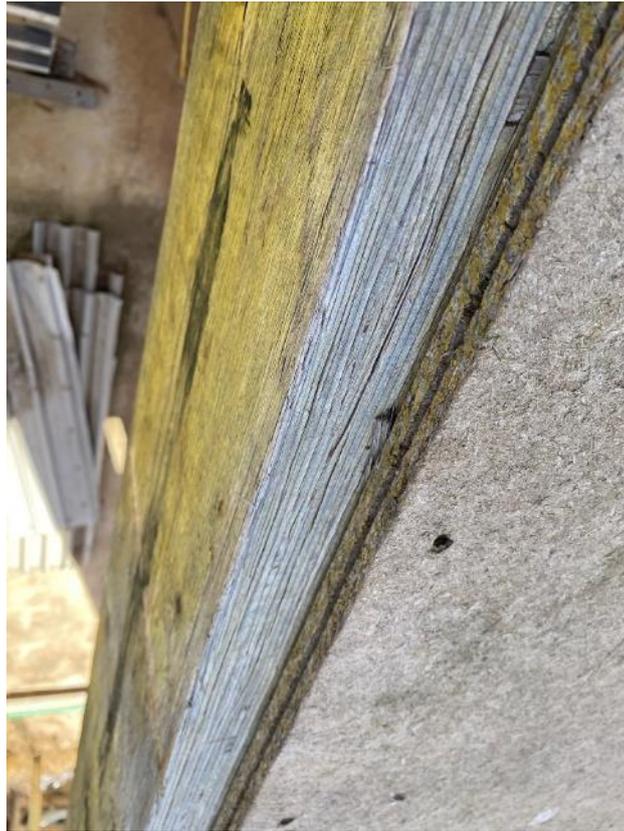
Figure 11. Splitting of the timber beam supporting the eastern wall above the garage area. Approximately 5.8 linear metres.

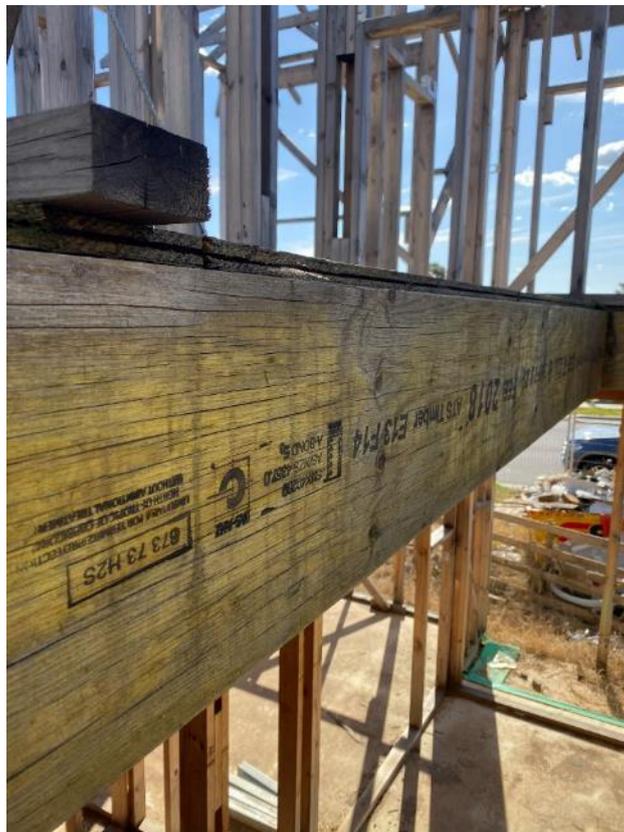
Figure 12. Timber splitting to the timber beam on the eastern wall above the garage area. Approximately 5.8 linear metres.

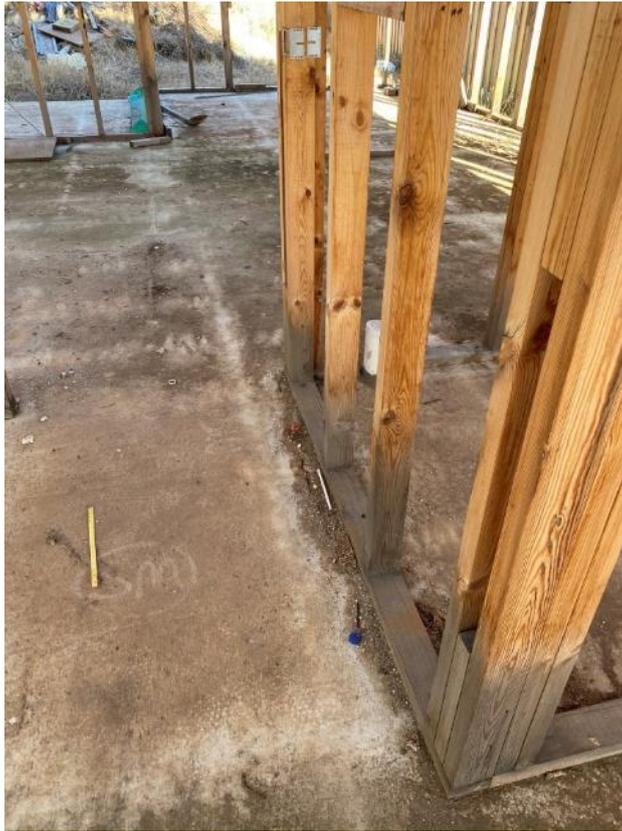
Figure 13. Water damage to the ground floor timber frame near the powder room.

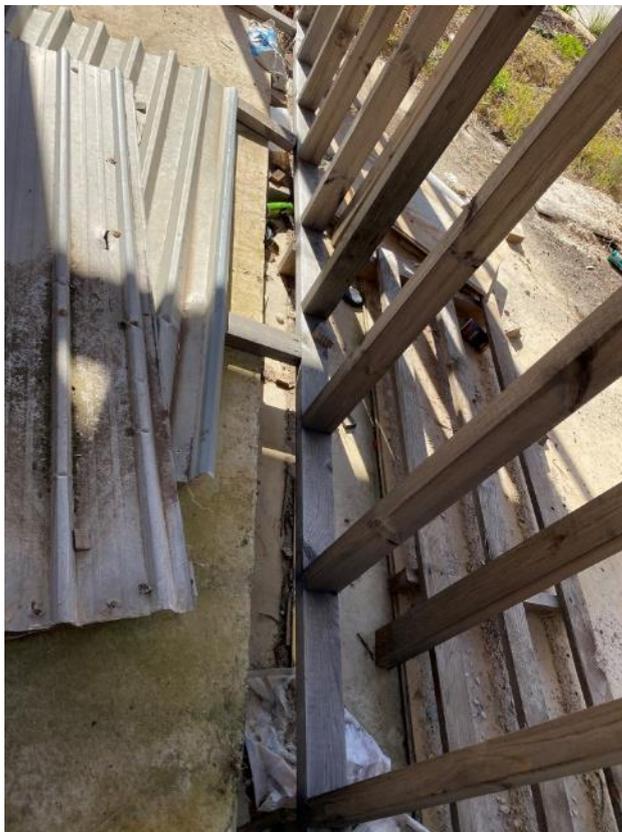
Figure 14. The timber frame to the garage wall has not been constructed on the rebate of the concrete slab.

Construction of a concrete step is required in order to rectify item 1 in section 9.1 to allow for supports of the timber stud wall in the garage area. The construction of the step will be 200mm in width, 85mm in height and 5800mm in length. No alternative construction measures are recommended due to the load-bearing nature of the garage wall.

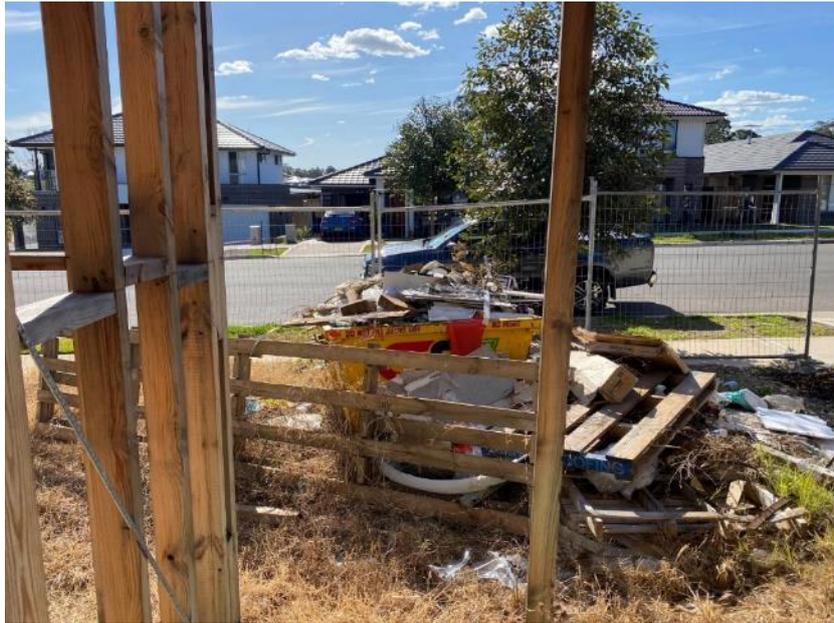
Figure 15. Construction debris has been stock piled at the front of the dwelling. Approximately 10m³ in size.

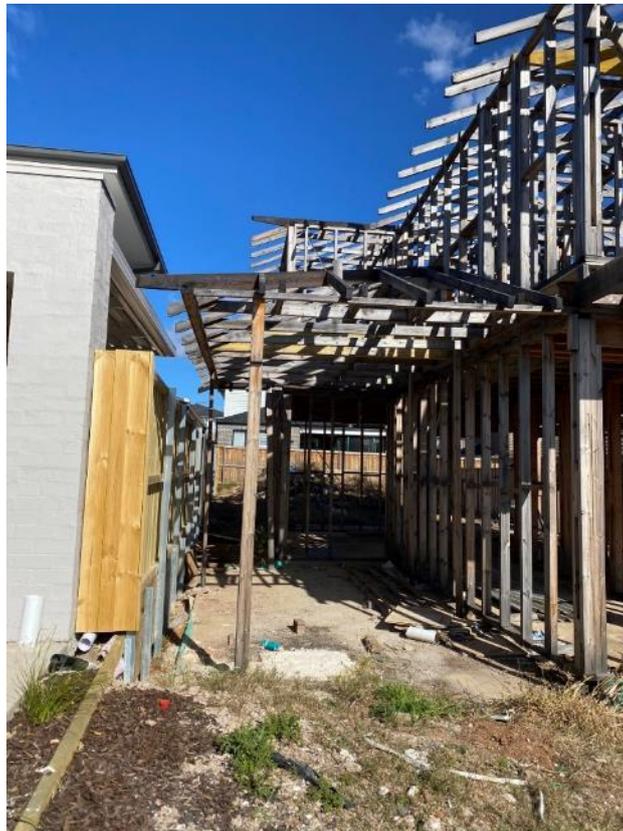
Figure 16. The temporary support to the garage roof is weathered and the eave overhang is not constructed in accordance with the contract drawings.

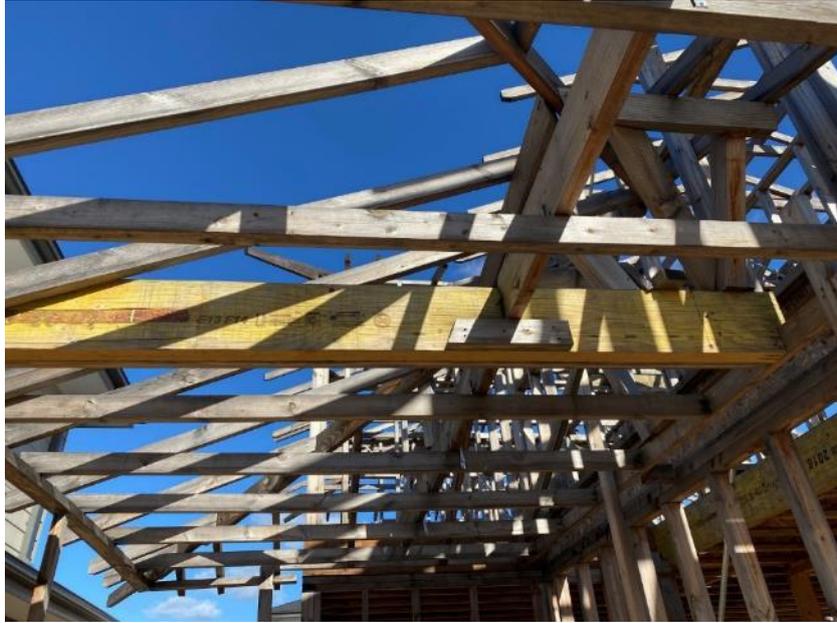
Figure 17. Weathered timber in the garage roof area.

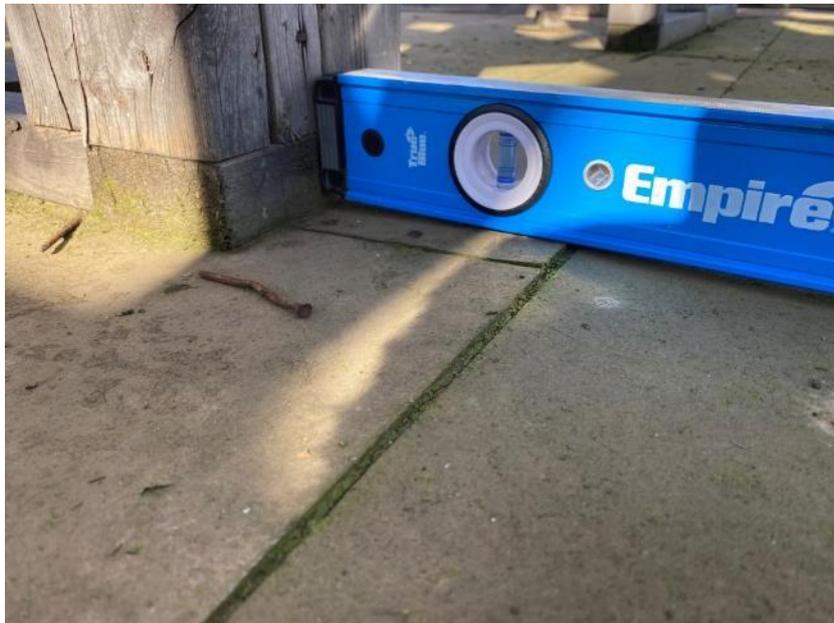
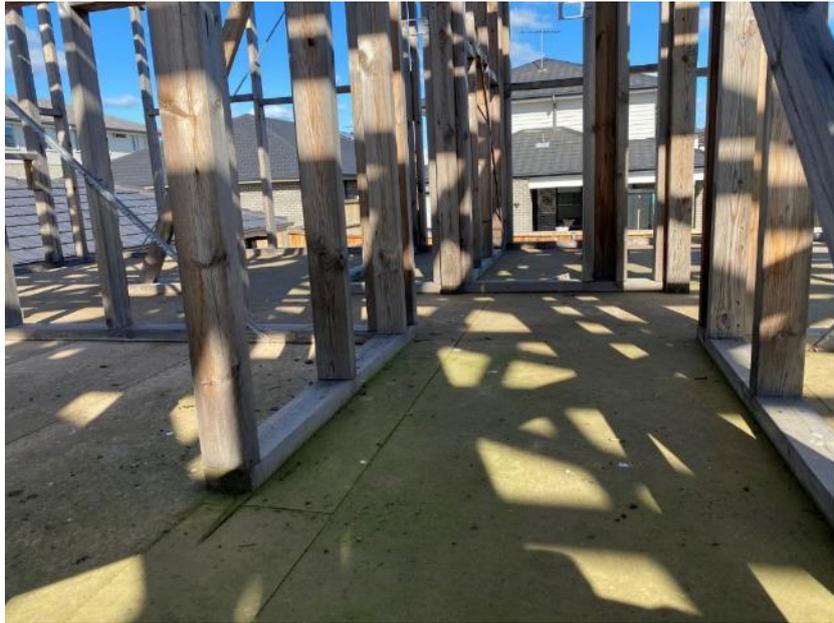
Figure 20. Moss growth found to the timber particleboard flooring to the first floor.

Figure 21. Moss growth to the timber particleboard flooring to the first floor.

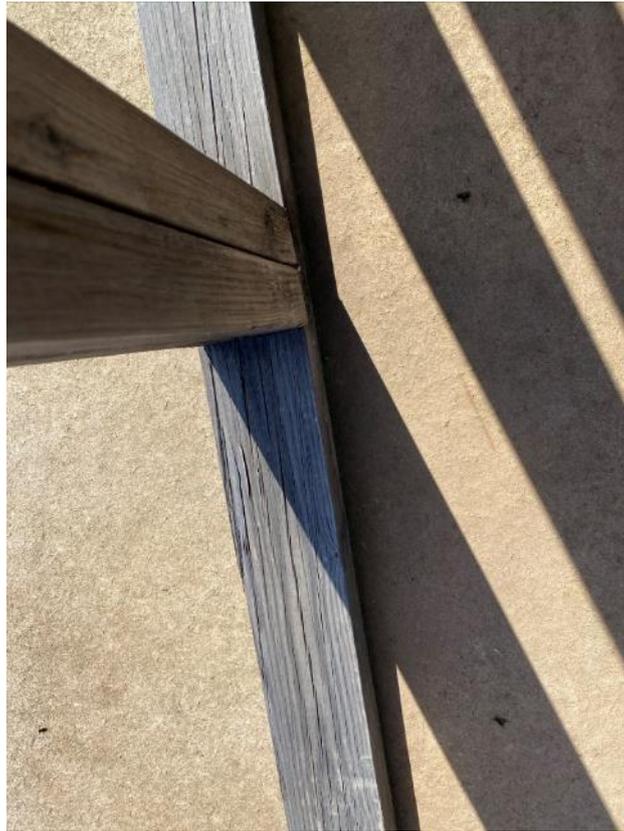
Figure 23. Water damage noted to the timber frame of the first floor wall structure.

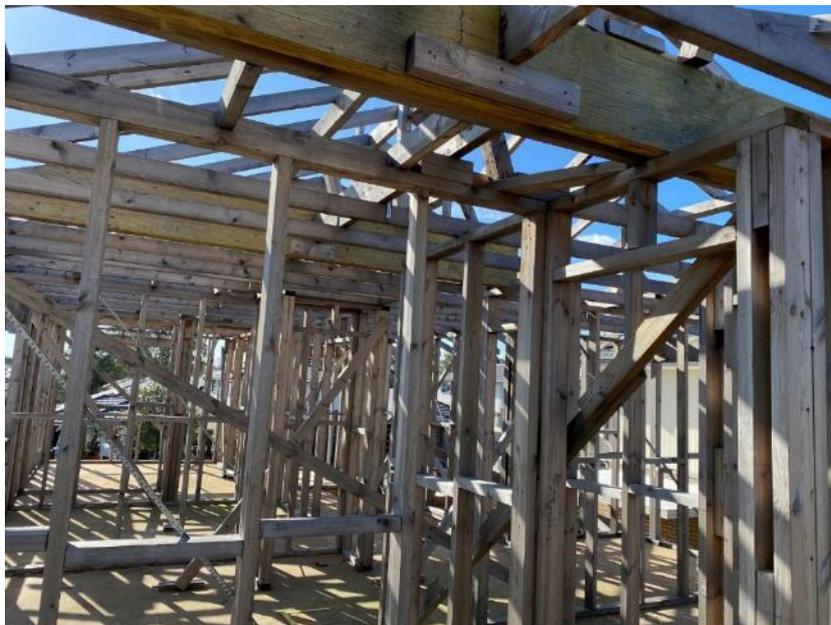
Figure 24. Water damage to the timber frame of the first floor wall structure.

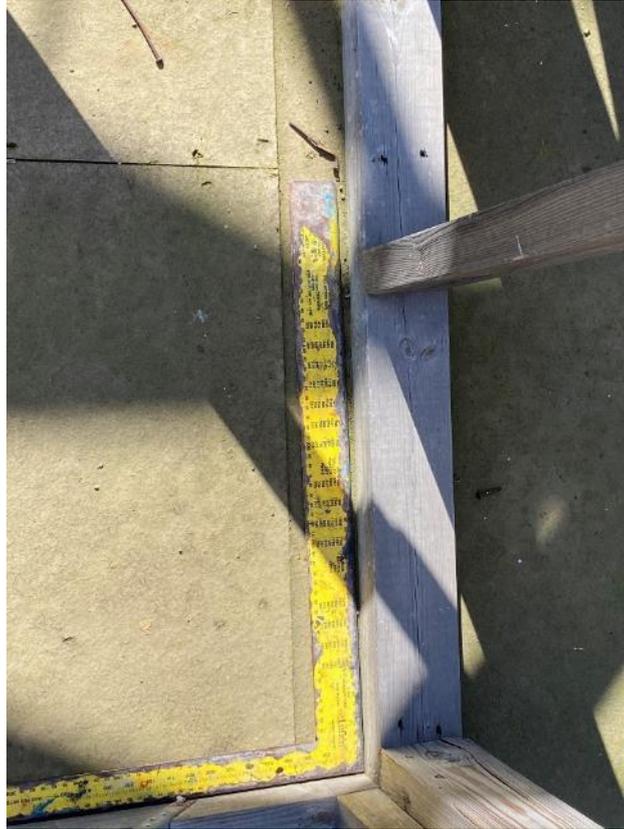
- 7) The Builder has failed to correctly install the timber frame. Figure 25 in Appendix C shows that the timber frame has deviated 5mm in 50mm of wall. This contravenes the New South Wales Fair Trading Guide to Standards and Tolerances, Part 4.3 Straightness of steel and timber frame surfaces, which states

“Frames are defective if they deviate from plane by more than 4mm in any 2m length of wall.”

Figure 25. The timber frame has not been constructed square and has deviated 5mm in 500mm.

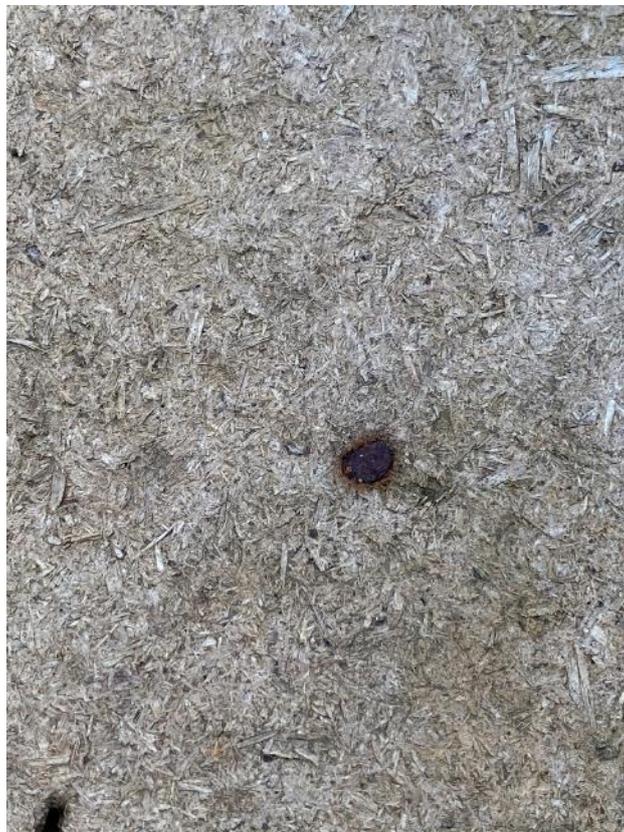
Figure 26. The nail fixings have corroded and require replacement.

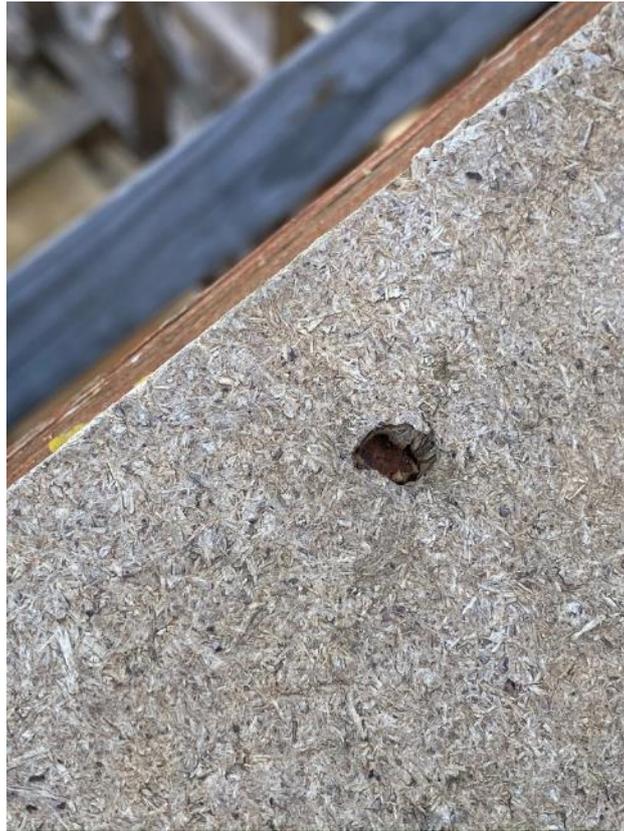
Figure 27. The nail fixings to the particleboard floor sheeting have corroded.

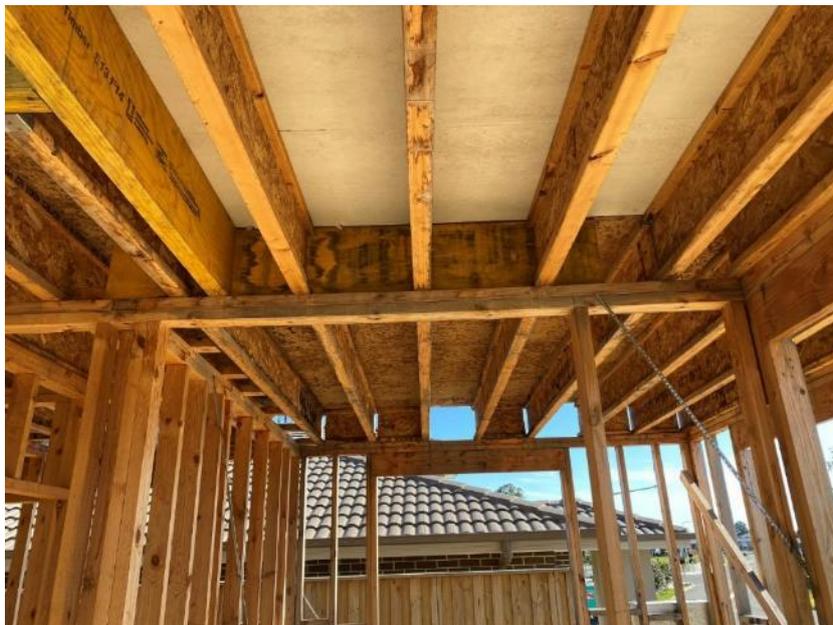
Figure 28. Water damage to the timber floor joists in the lounge room area.

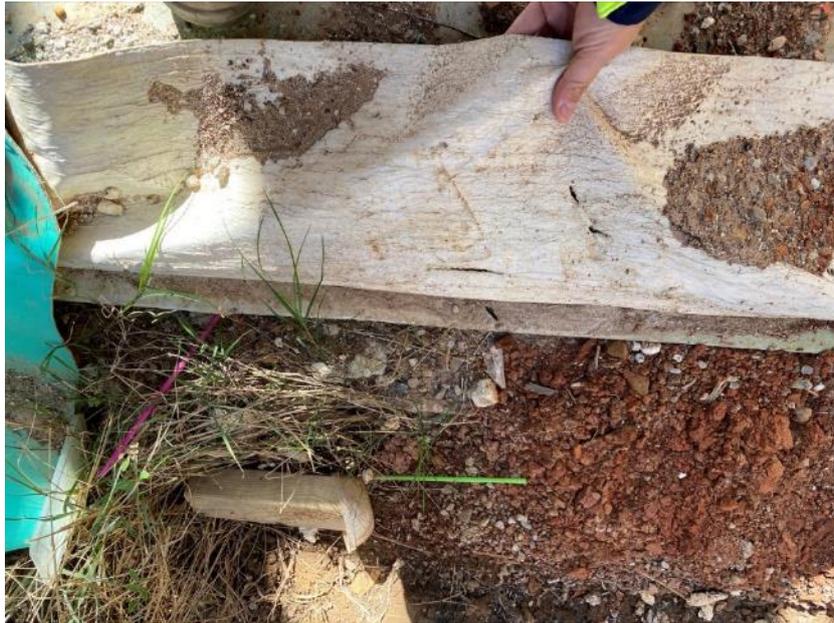
- 8) The termite barrier system installed around the perimeter of the dwelling has been impacted by weather. As the membrane used for termite protection has been exposed to weather for 18 months, it is not suitable for re-use upon resumption of construction of the dwelling. There is evidence of water entry to the membrane and the top and base layer of the membrane is flaking in various areas. Notwithstanding this, a termite protection notice has not been provided and therefore contravenes Part 2C – Section 18B of the Home Building Act. Figures 29 and 36 in Appendix C show images of the failed termite barrier.

Figure 29. The termite barrier is water damaged and requires replacement throughout the dwelling. Approximately 43 linear metres.

It is recommended to remove and replace the termite barrier system as outlined in item 8 of section 9.1. Replacement of the termite barrier is required because a termite protection notice has not been provided by the Builder. Notwithstanding this, the exposure of the membrane to weather has resulted in deterioration of its components, this resulting in an inadequate termite protection system if the products are re-used. An alternate to the replacement of the termite membrane is through chemical injection or the installation of a termite baiting system, however these systems are not the most economical option in this situation.

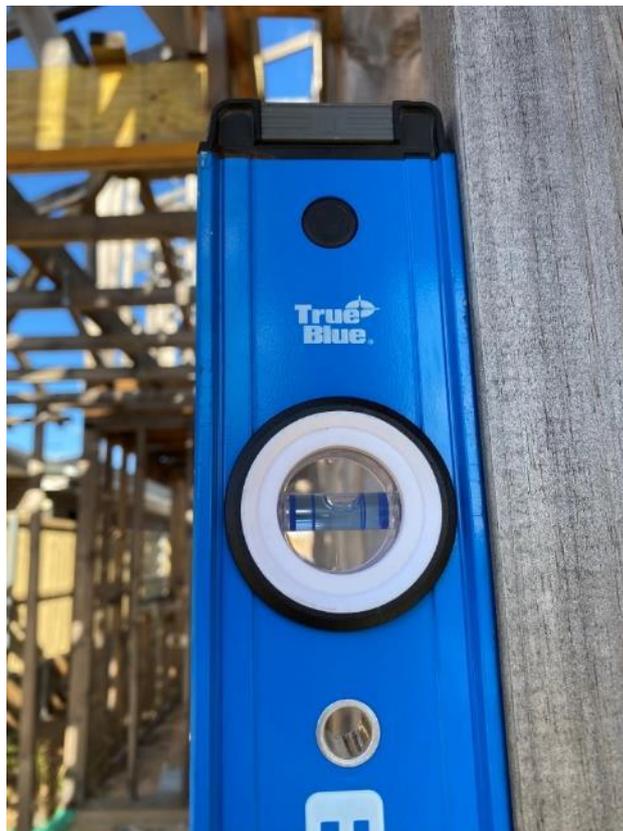
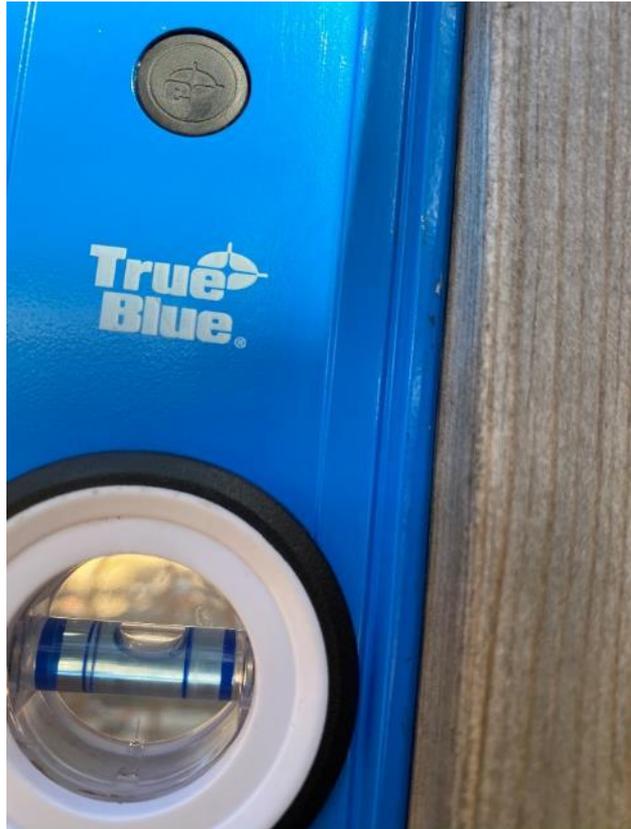
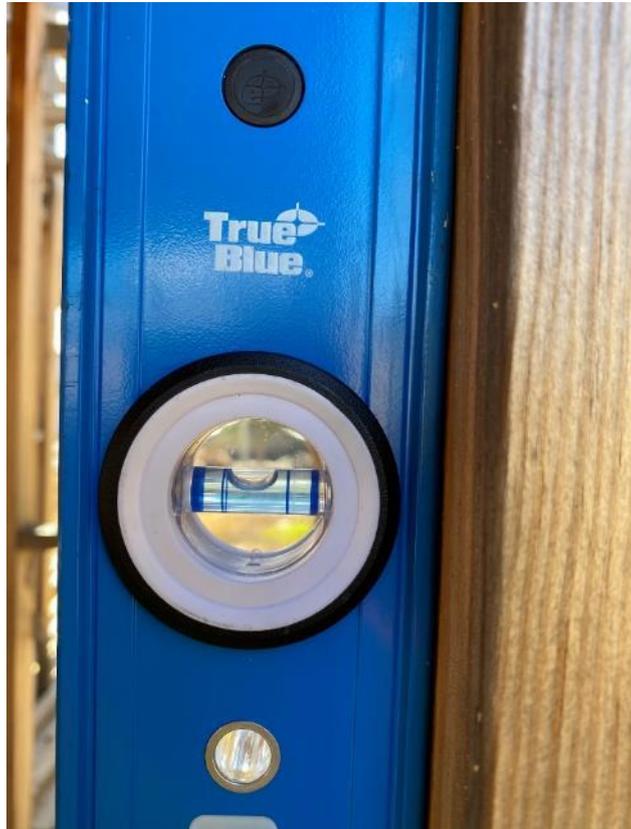
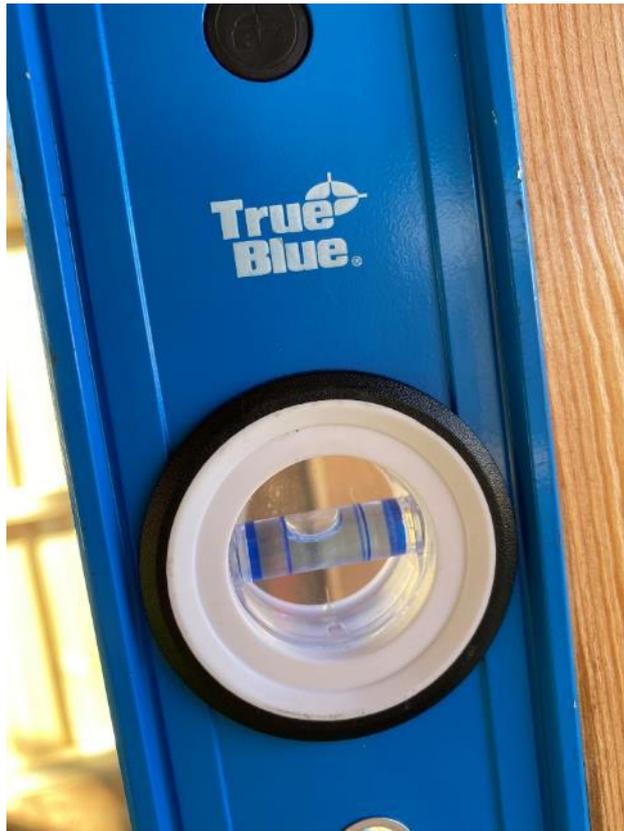
Figure 30. The timber wall frame in the garage area is not straight and has deflected 2mm from the vertical.

Figure 31. The timber wall frame is not straight and has deflected 2mm from the vertical.

Figure 32. The timber wall frame is not straight and has deflected 2mm from the vertical.

Figure 33. The timber wall frame is not straight and has deflected 2mm from the vertical.

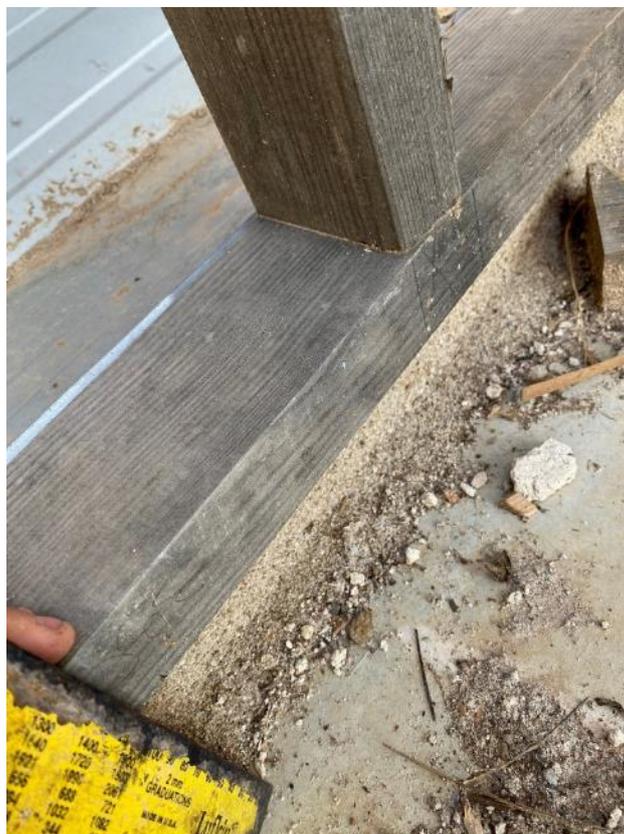
Figure 34. The timber bottom plate is water damaged and requires replacement.

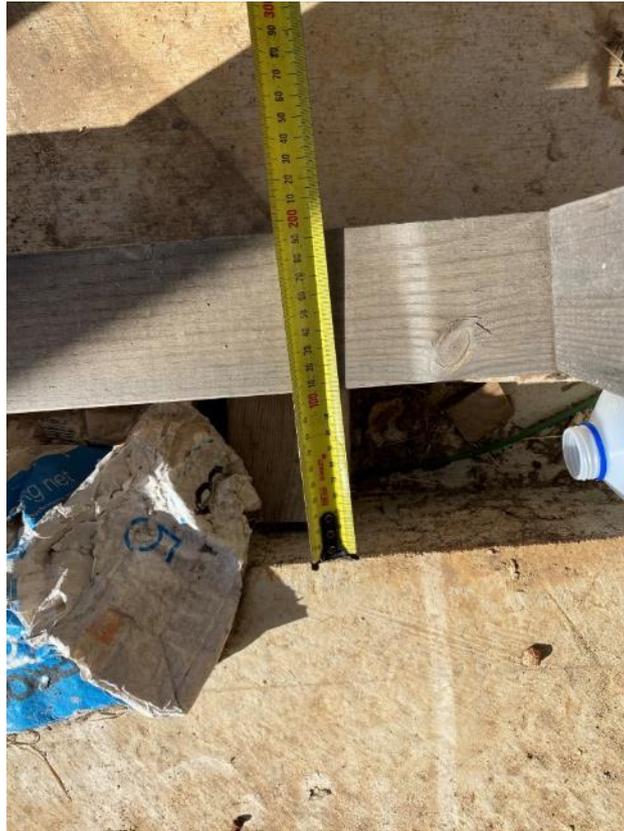
Figure 35. The concrete step down to the garage area has been constructed 200mm shorter than the architectural drawings.

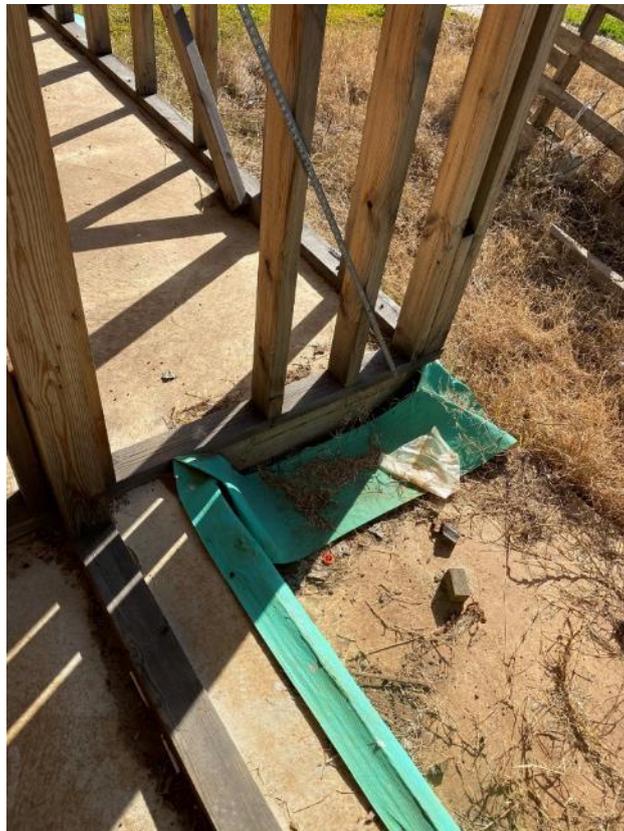
Figure 36. The timber frame/concrete slab in the porch area has not been constructed in accordance with the architectural drawings. The termite barrier has been applied to the edge of the concrete slab, which does not sit directly underneath the timber frame.

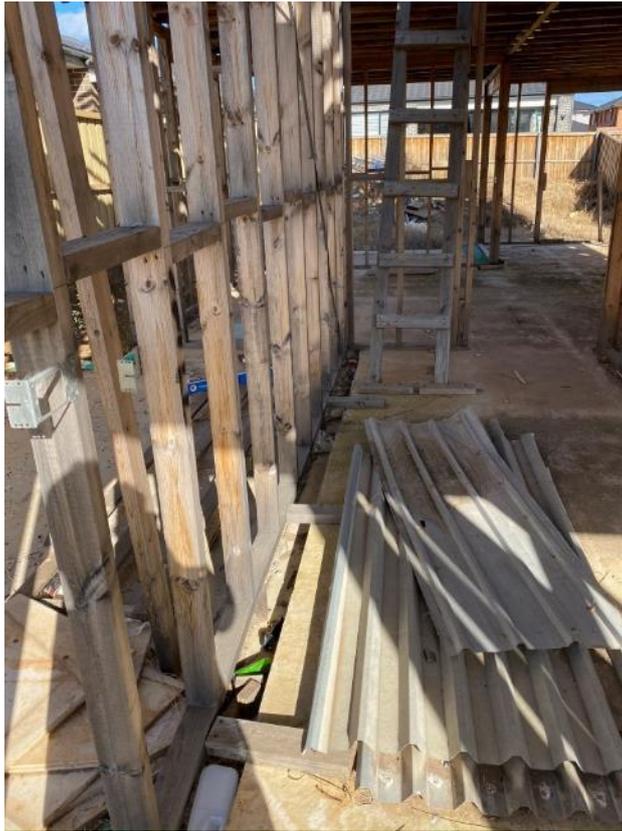
Figure 37. The timber frame to the garage wall has not been constructed on the rebate of the concrete slab.

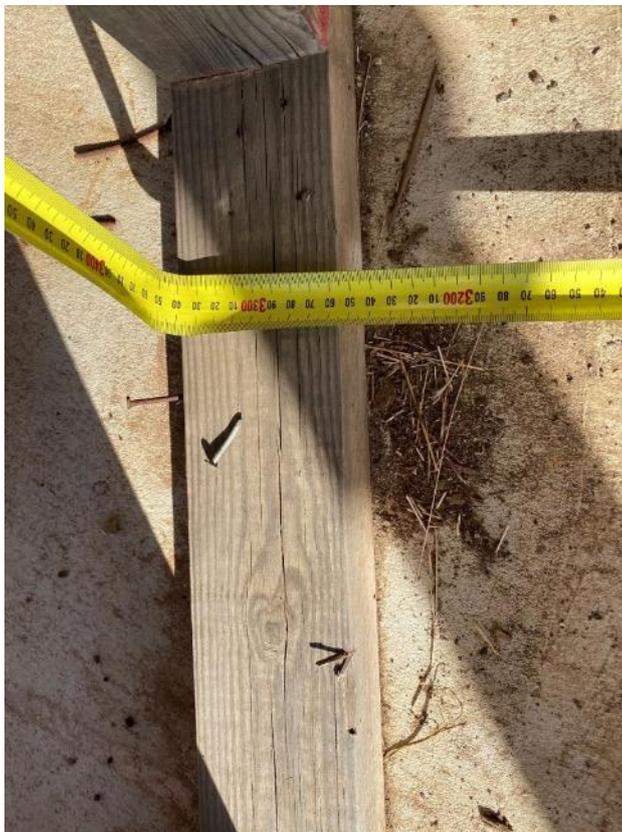
Figure 38. There is evidence of splitting to the timber base plate.

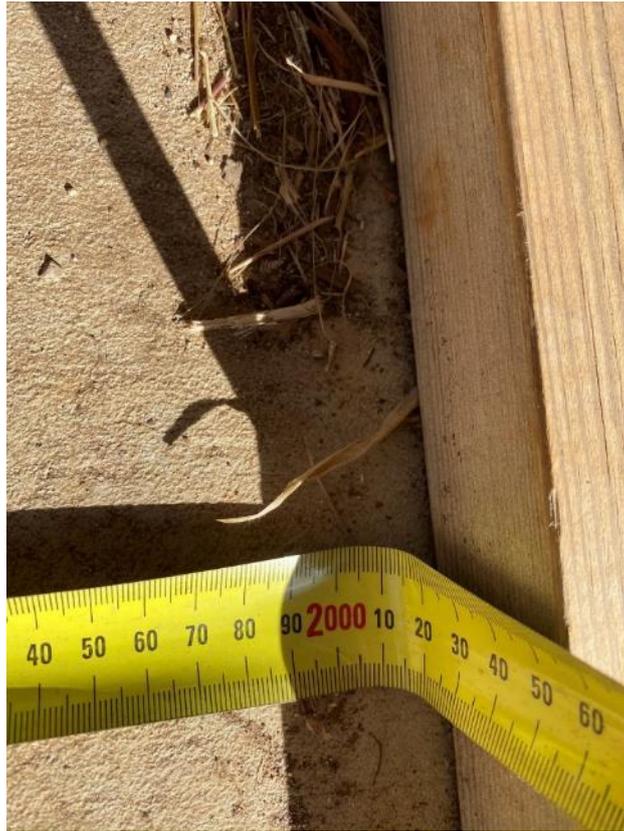
Figure 39. The wall opening in the entry area has not been constructed in accordance with the architectural drawings. There is a 100mm deviation from the plans.
