Building Investigations Report

9 SUMMARY OF FINDINGS, OPINIONS AND CONCLUSIONS

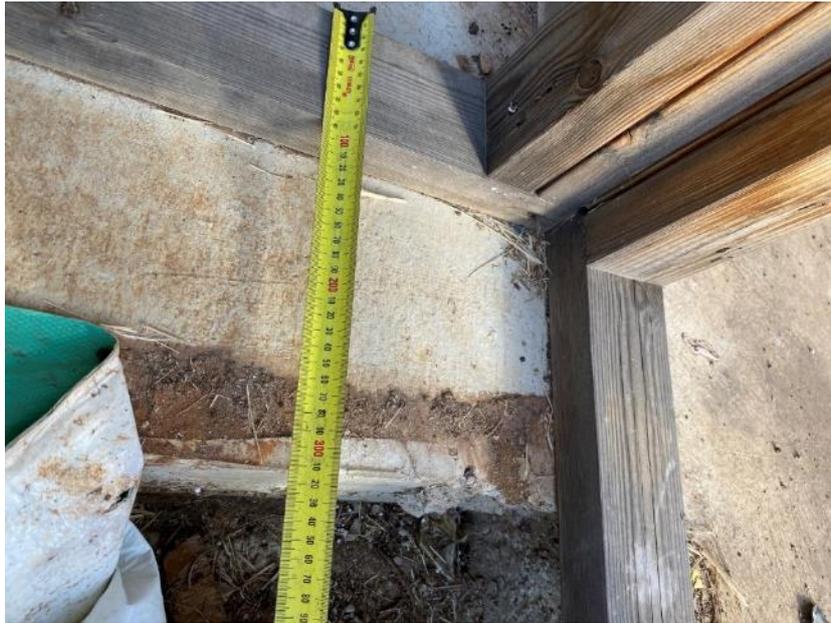
Figure 41. The concrete slab to the porch area has been constructed 200mm from the building line, which is 800mm shorter than required in order for completion of the porch area.

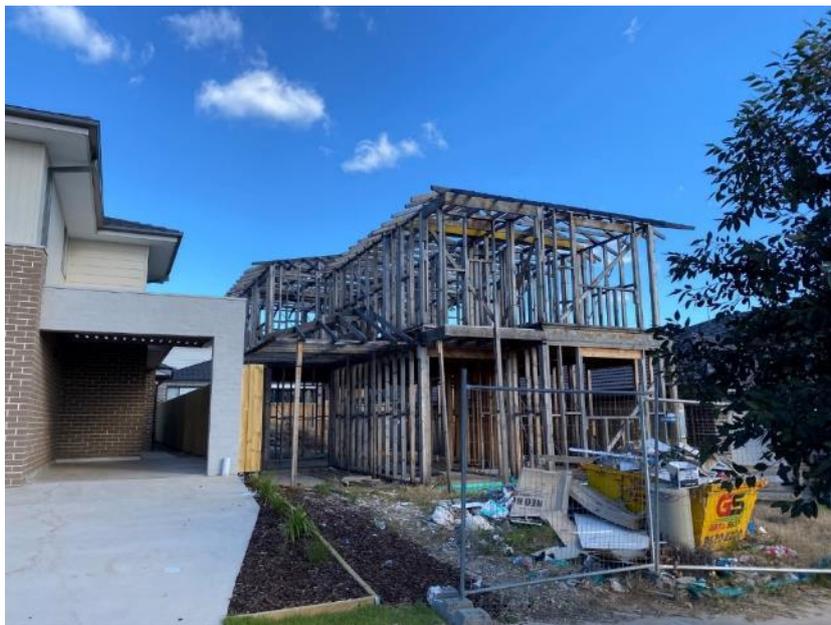
Figure 42. The side panels to the temporary fence are missing and require reinstatement. Total length required is 10 metres.
