Thermal Timber Pest Inspection Report

40 Burdekin Cr, St Ives, NSW 2075

Inspection Date and Time: 07-Jun-12 1:00:00 PM

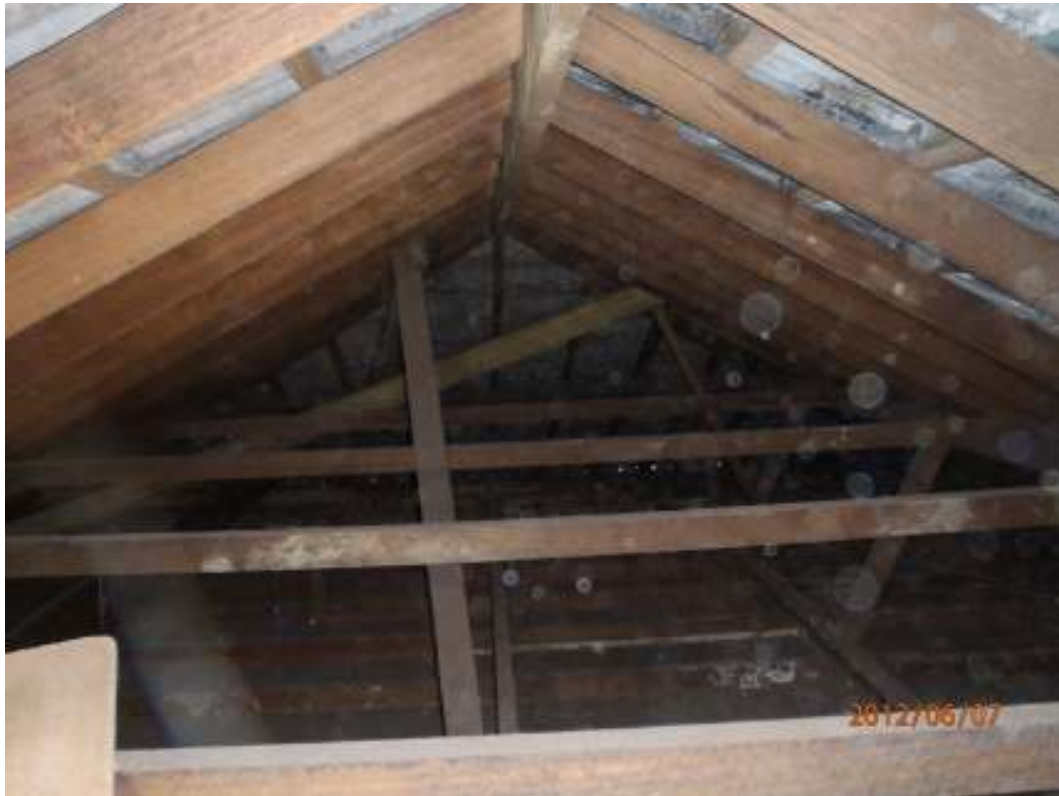
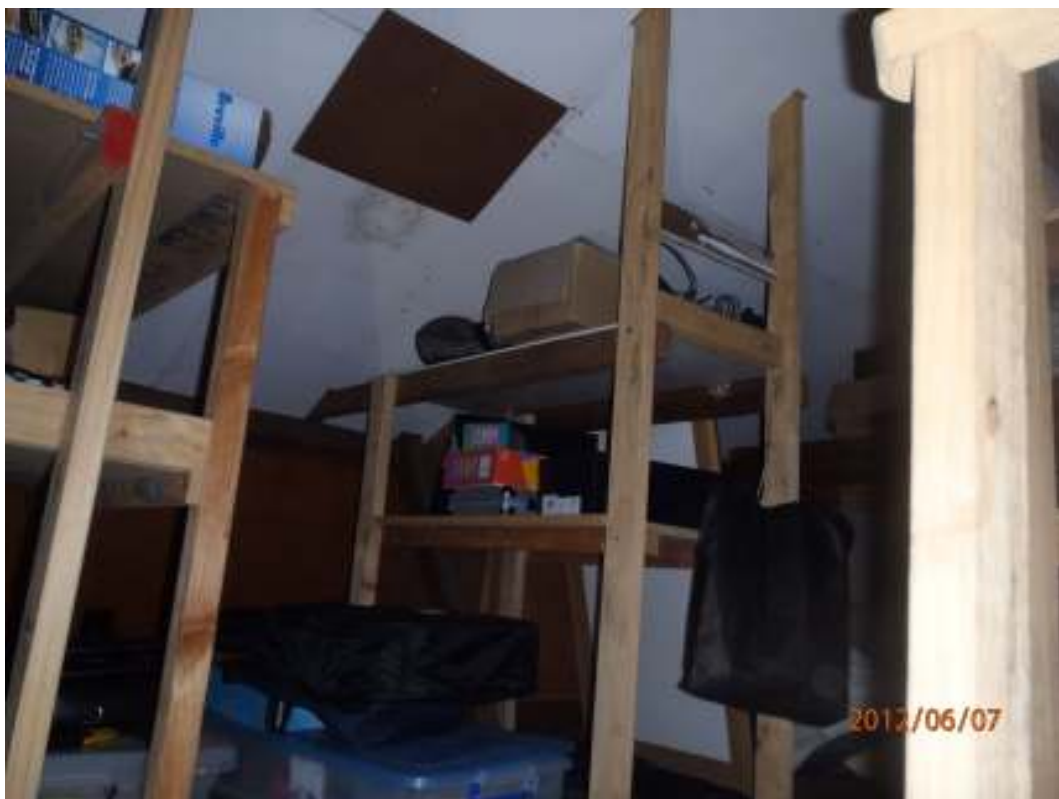
Photos for Inaccessible Areas

Parts of the internal roof space was not accessible due to storage.

RECOMMENDATION: Where the risk is considered “*Moderate*” or “*Moderate-High*” or “*High*”, a further inspection is strongly recommended of areas that were not readily accessible, and of inaccessible or obstructed areas once access has been provided or the obstruction removed. This may require the moving, lifting or removal of obstructions such as floor coverings, furniture, stored items foliage and insulation. In some instances, it may also require the removal of ceiling and wall linings, and the cutting of traps and access holes. Seek further advice from your Consultant.

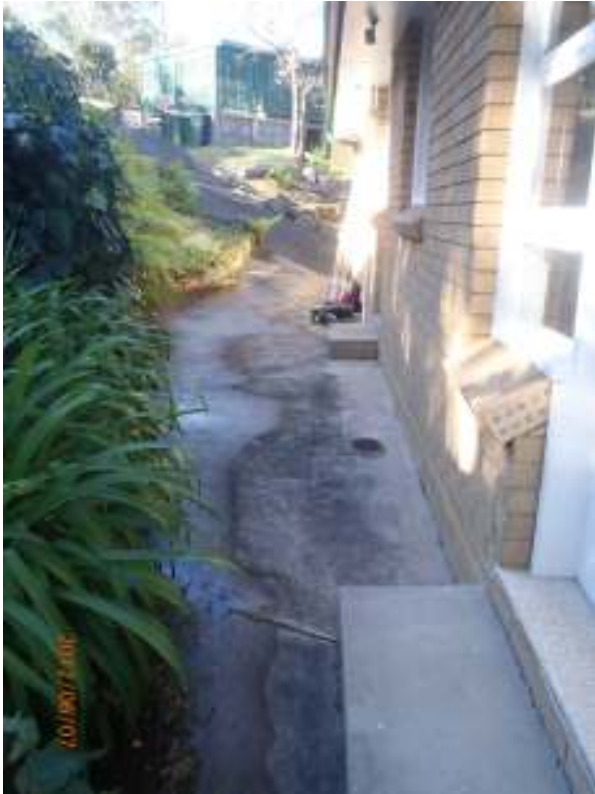
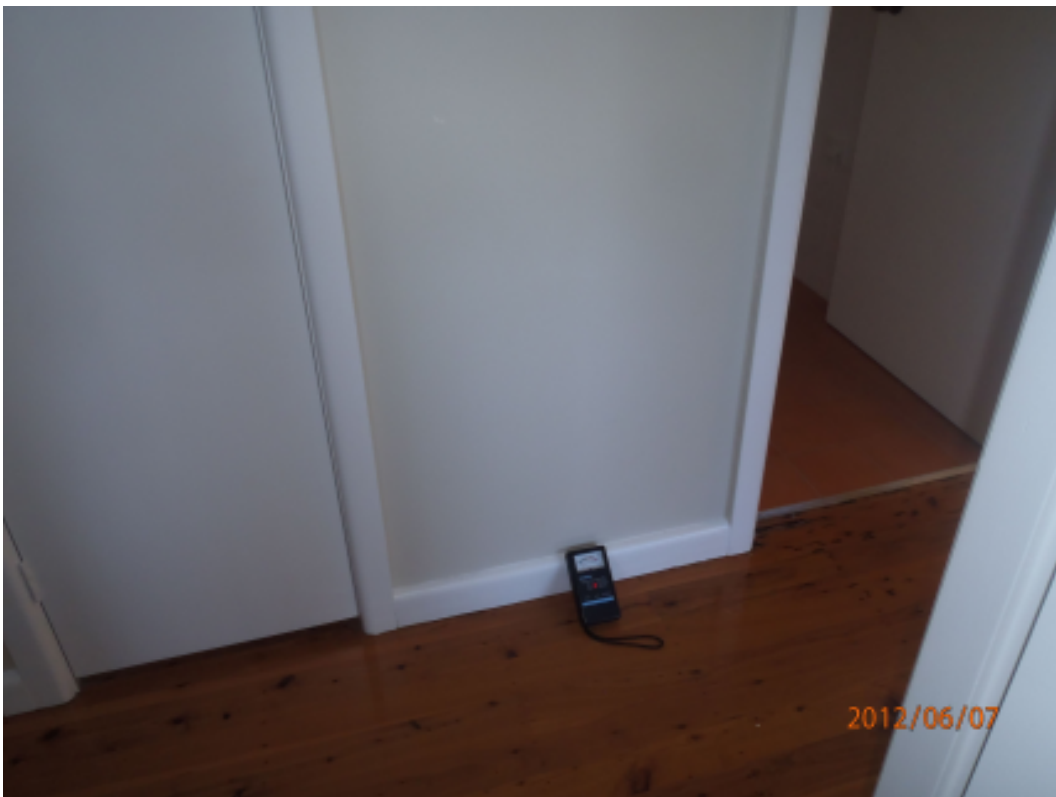
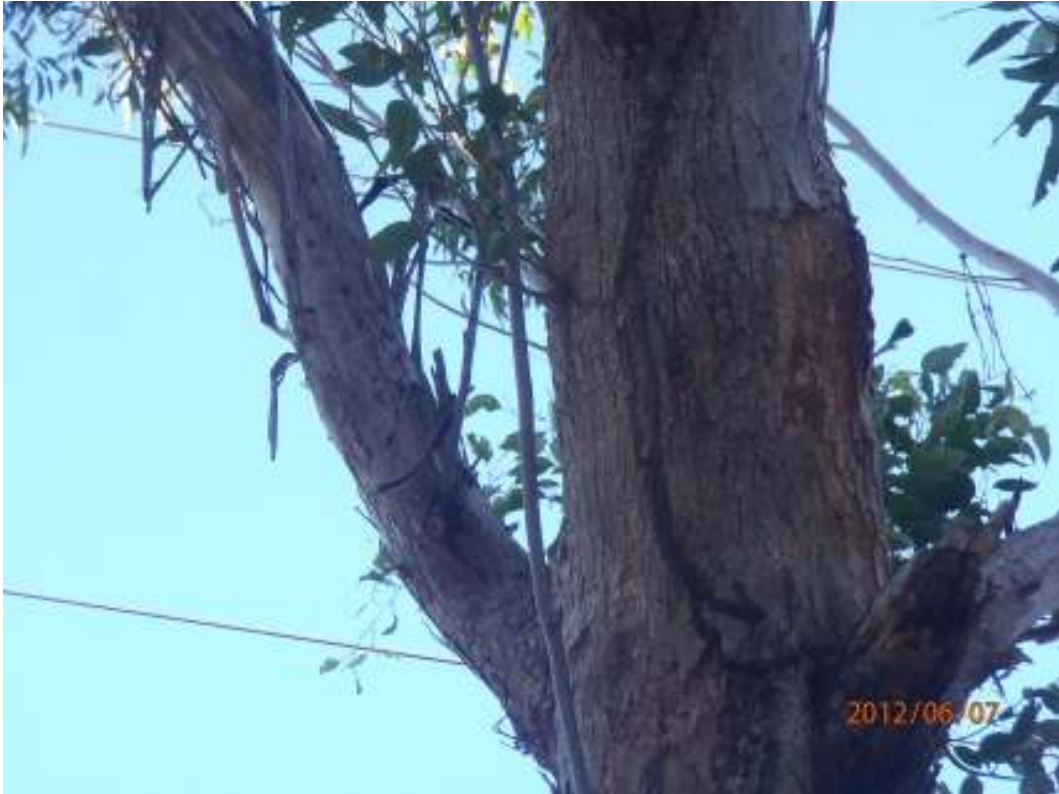
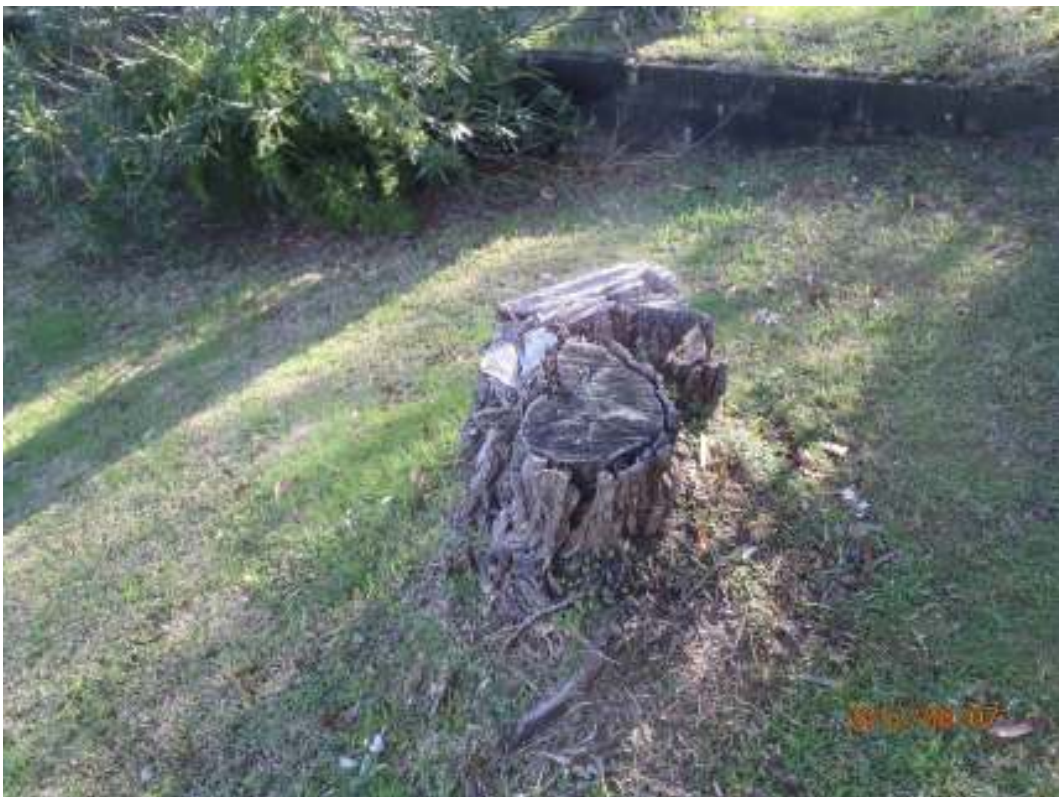
Photos for Undetected Termite Risk Assessment

The termite risk is high due to high moisture metre readings detected through out the property and evident termite tracking sighted within 10 metres of the property.

It is recommended a Aggline drainage system is installed around the property and a spoon drain is put in place.

A termite barrier management system is also recommended to prevent a termite attack.
It is recommended tree stump is removed as it is a excellent food source for termites.

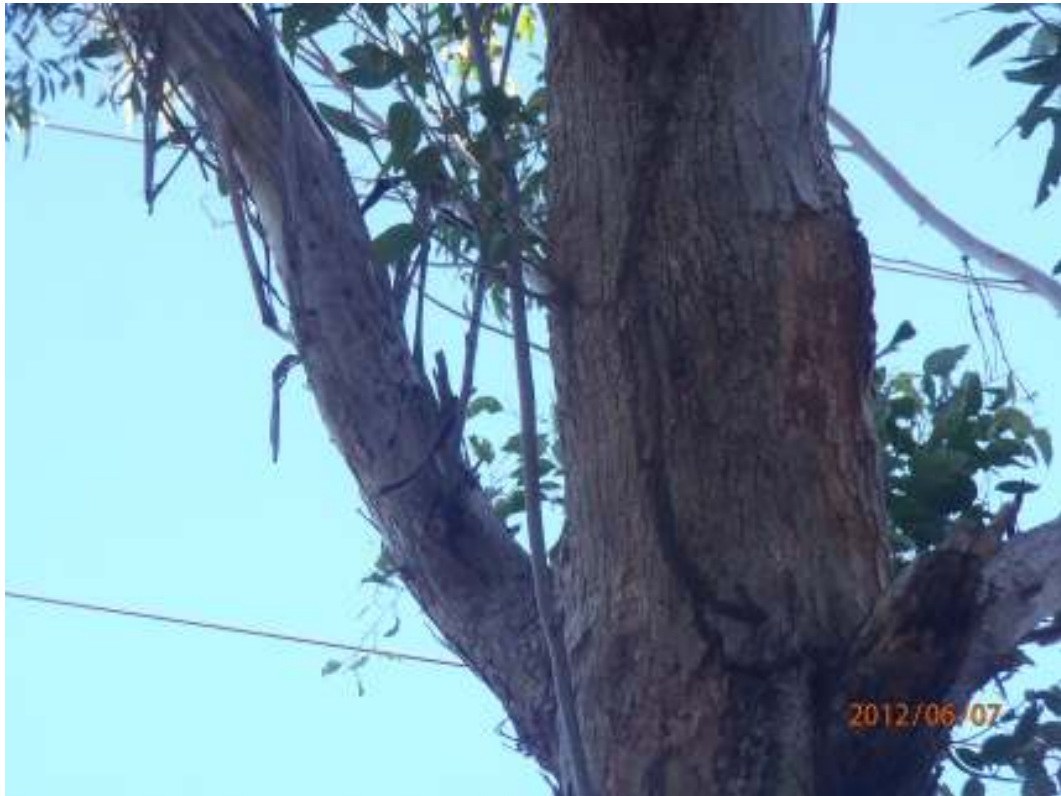
Photos for Termite Workings and/or Damage

Was evidence of termite workings or damage found? **YES**

The extent of any visible damage appears: **UNDETERMINED**

A termite barrier management system is also recommended to prevent a termite attack.

Where evidence of damage to building timbers exists, competent advice (e.g. from a licensed and practicing building contractor) should be obtained to determine the extent of any structural damage and as to the need or otherwise for rectification or repair work. See also *Item 3.5 - Frequency of Future Inspections* recommendation.

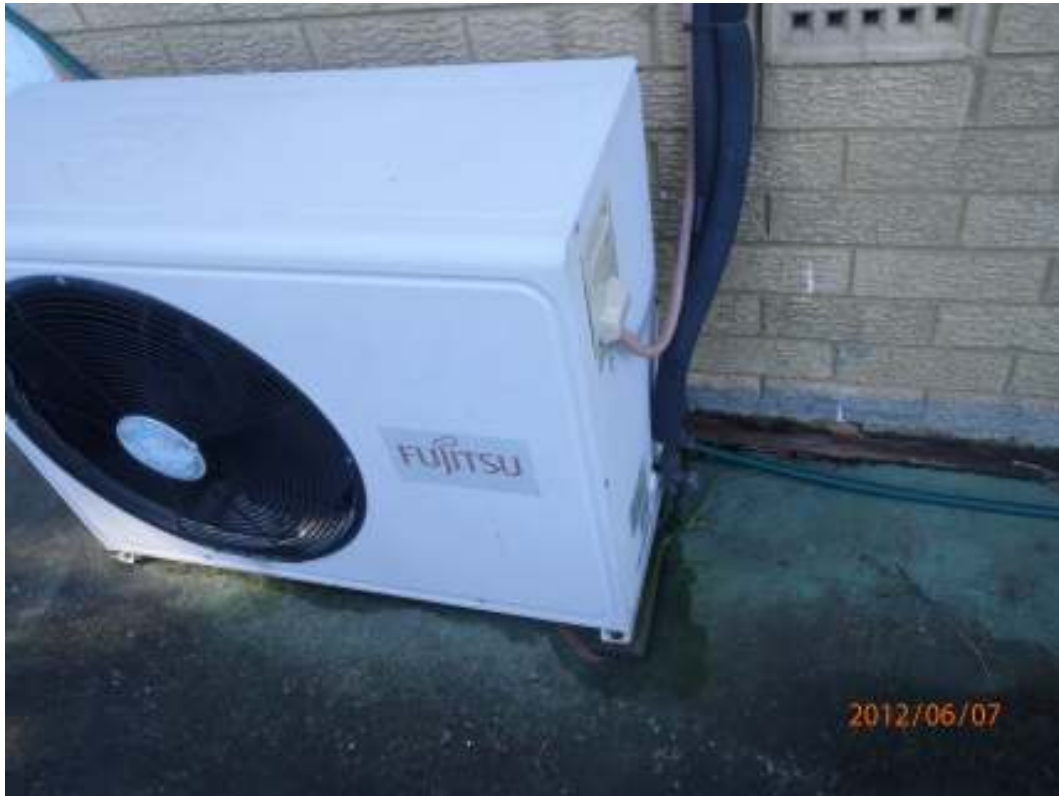
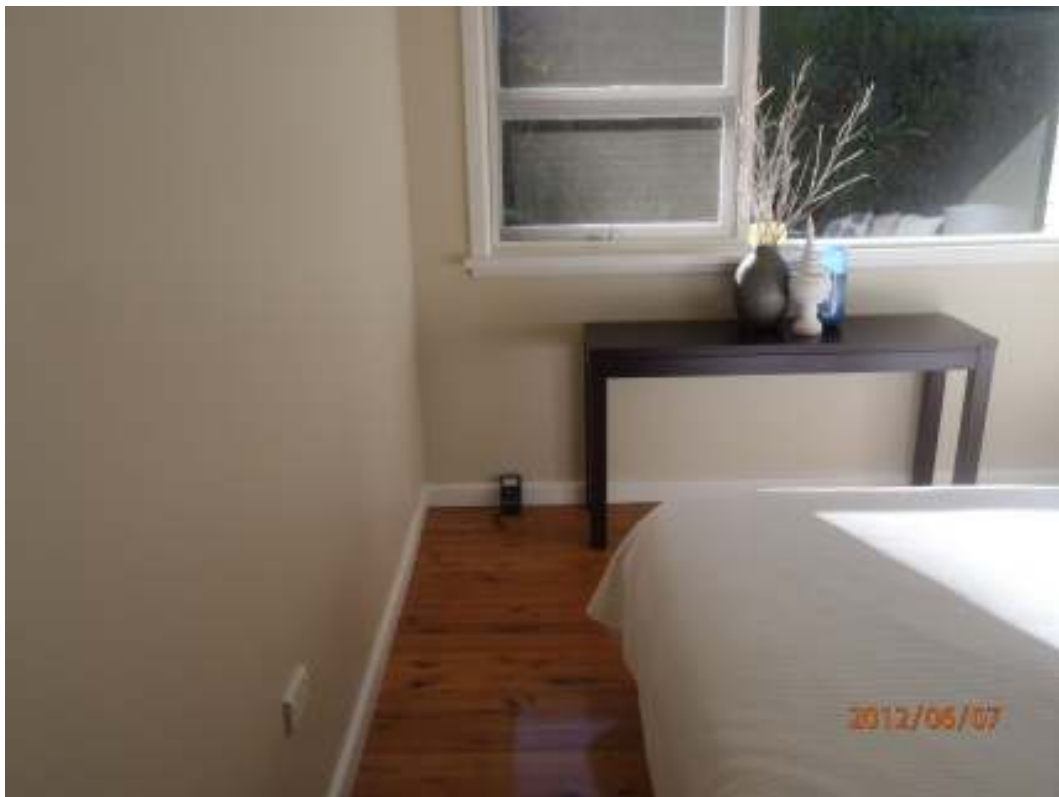
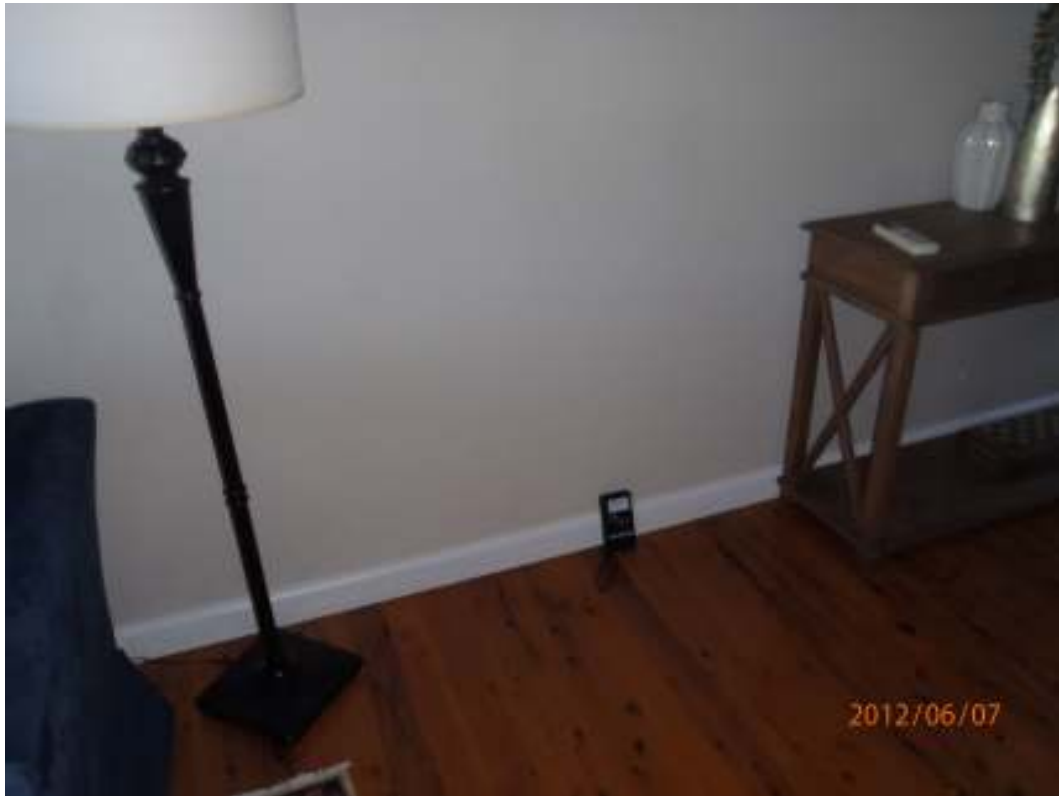
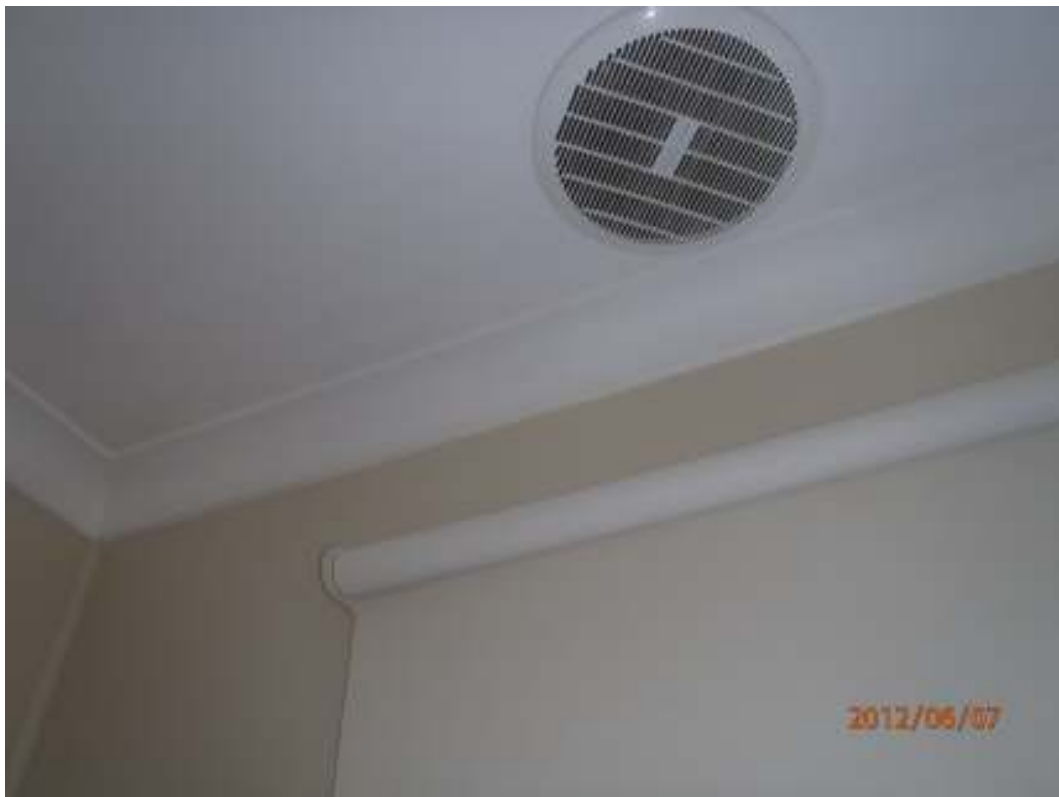
Photos for Presence of Excessive Moisture

Evident excess moisture sighted in the sub floor area due to lack of drainage, sloppy grounds and rocks sighted at the property.

High moisture metre readings were detected to approximately 70% of the property.

Evident mould growth sighted due to lack of ventilation and drainage. Evident signs of the paint been that has been placed over the mould growth appears to be reappearing. It is recommended a Aggline drainage system and additional ventilation is installed.

It is recommended the water leak from the external air-conditioner is fixed to prevent high moisture metre readings and mould growth.

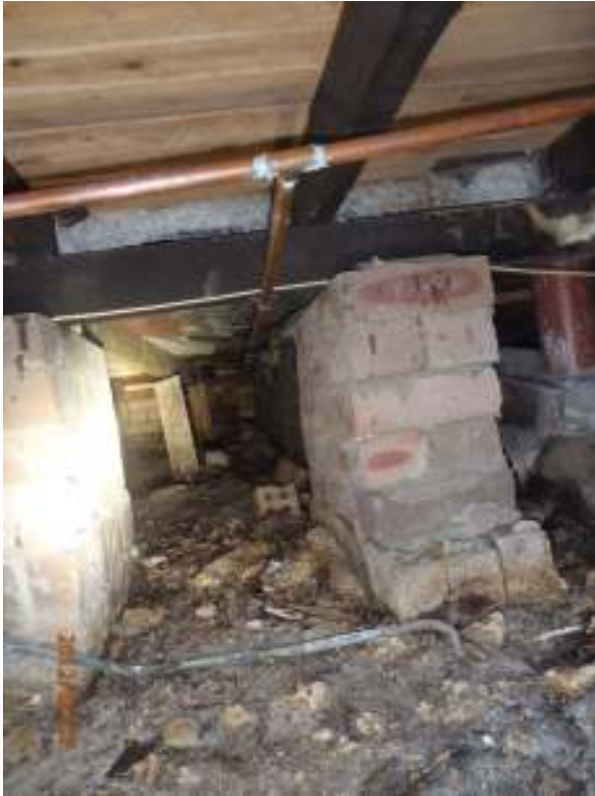
Photos for Earth-wood or Damp Masonry-wood Contact

Evident temporary support sighted within the sub floor area. It is recommended timber is removed as it is a perfect entry point for termites.
